70 visited Baltic mills in 2009
1 page per mill

Tour in July 2009 to 70 Baltic Mills in Saaremaa, Estonia, Latvia and Lithuania

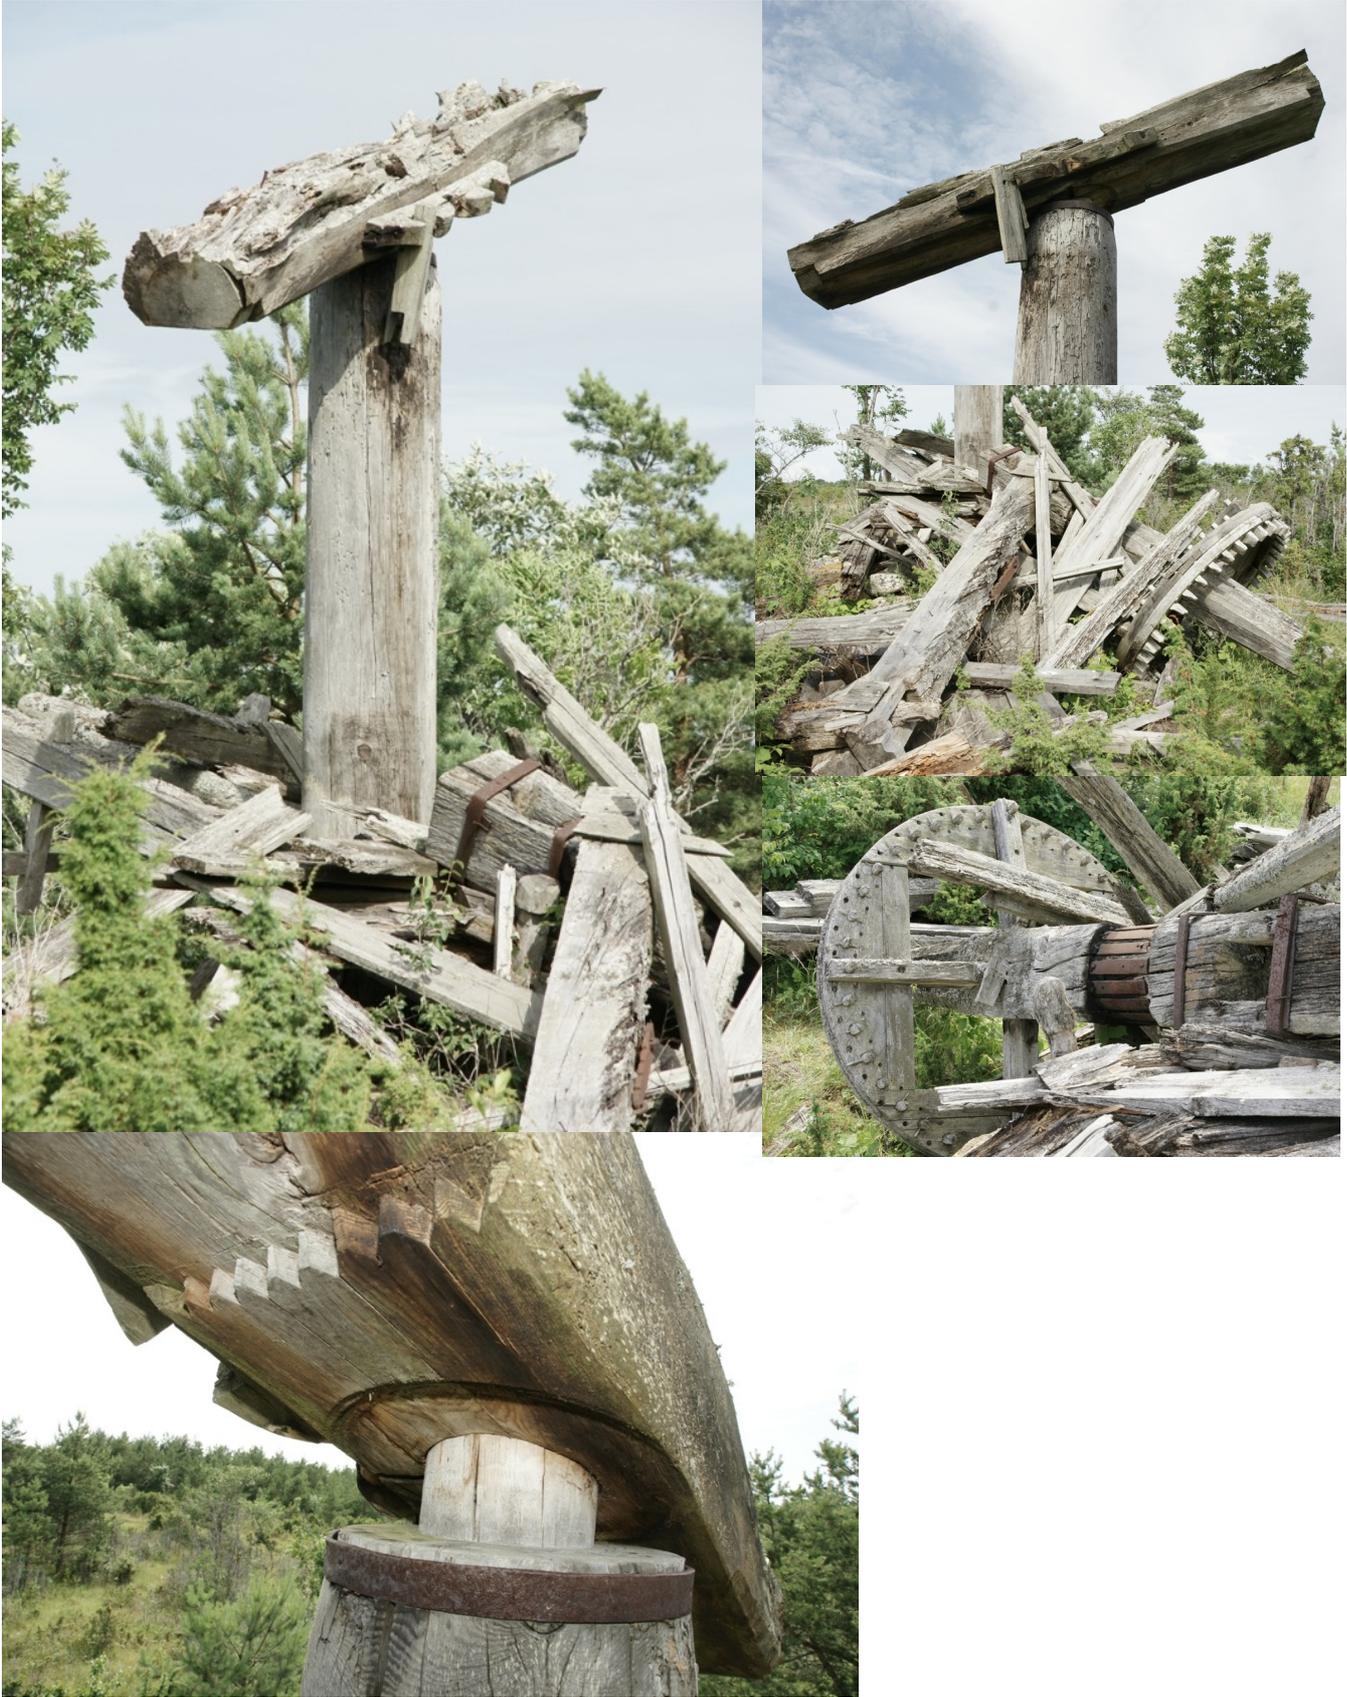
17 Kõruse3
Windmill, ruins

including broken millstone behind the tree.

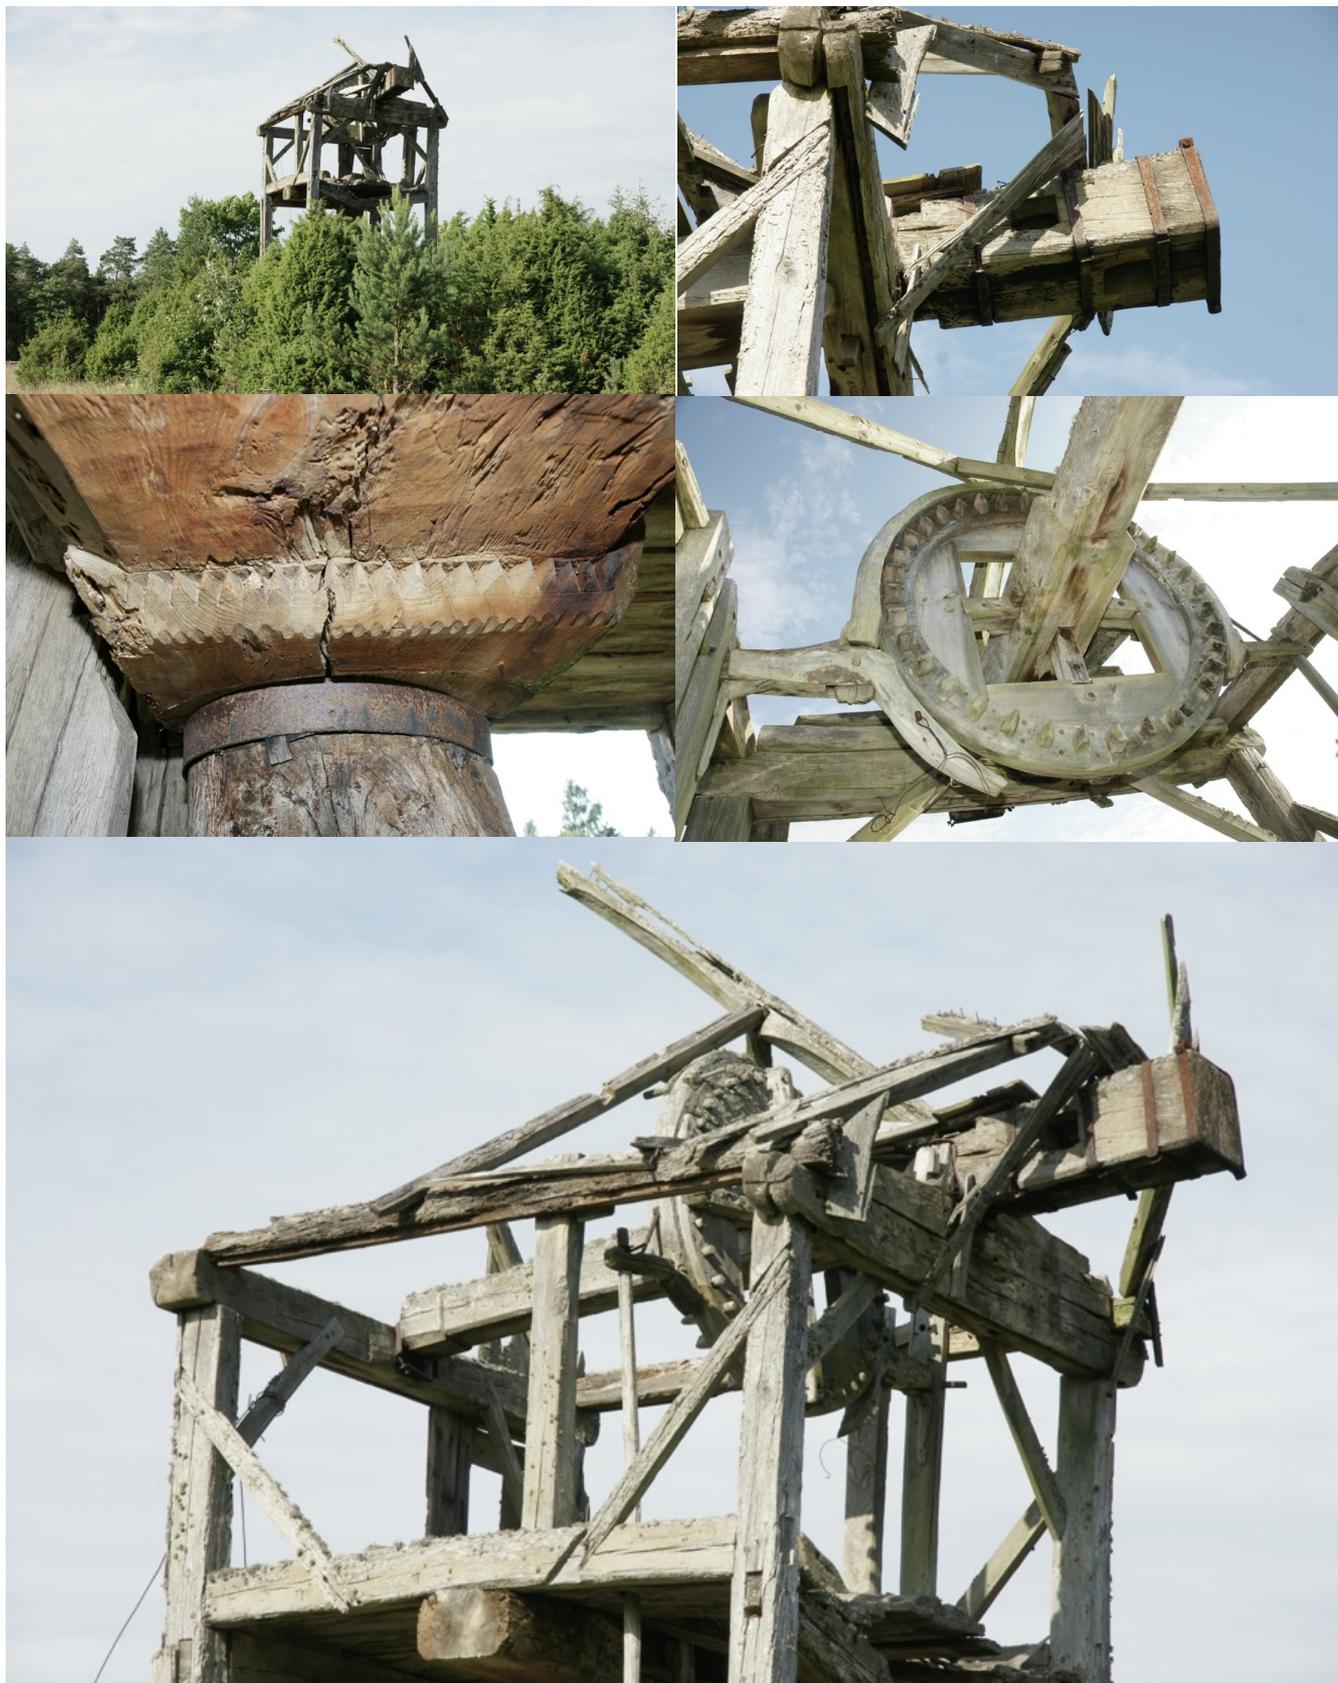
21 Viki
Windmill, ruins

Burned down in the beginning of 1990 ties.

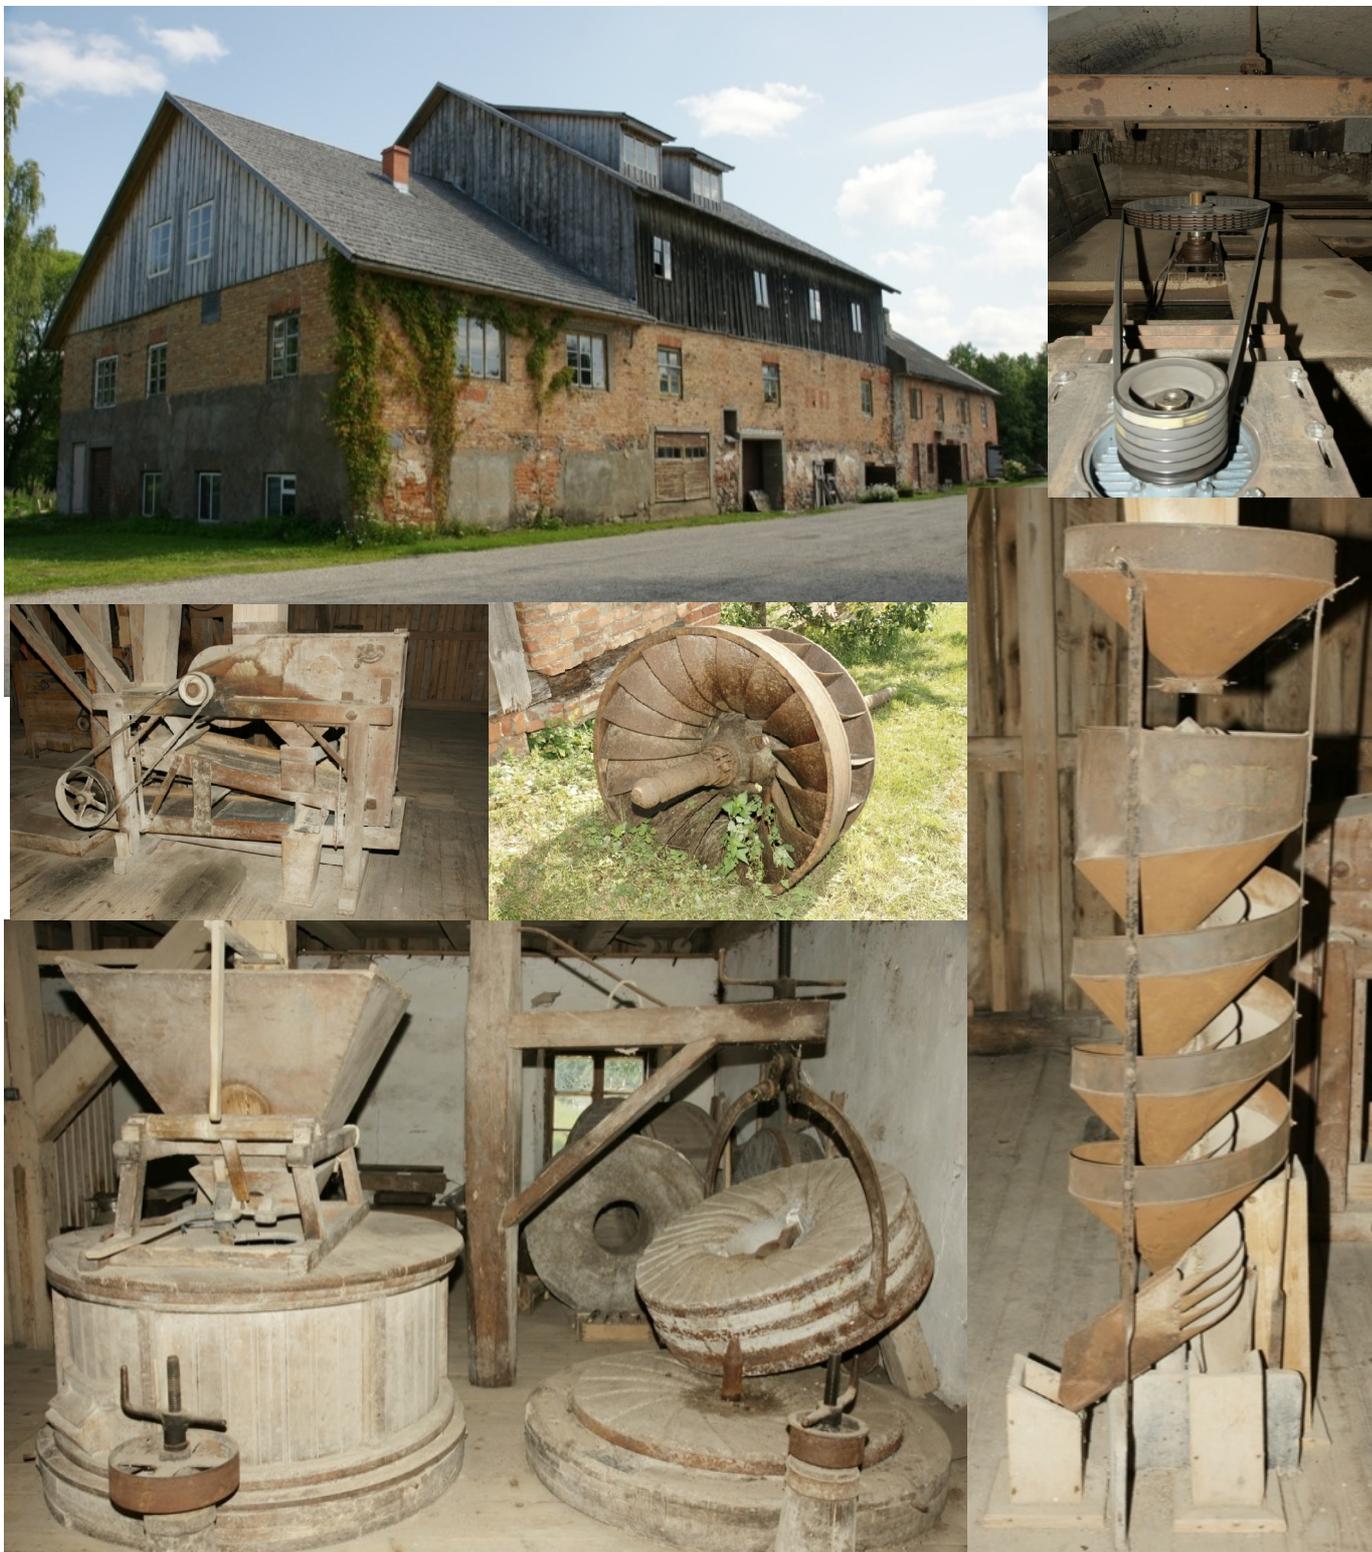
The mill is currently not in working order as the turbine shaft was damaged last year by accident. Some renovation works have been done since you were there: the mill has a new shingle roof and general maintenance works have been carried out by volunteers. Build in 1880.

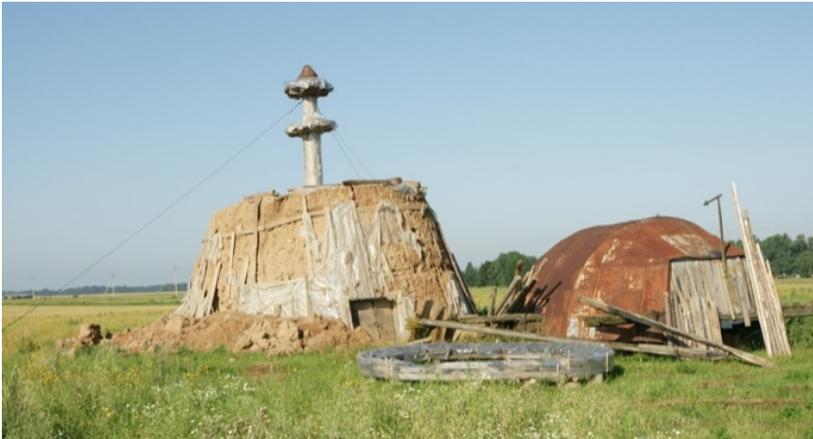
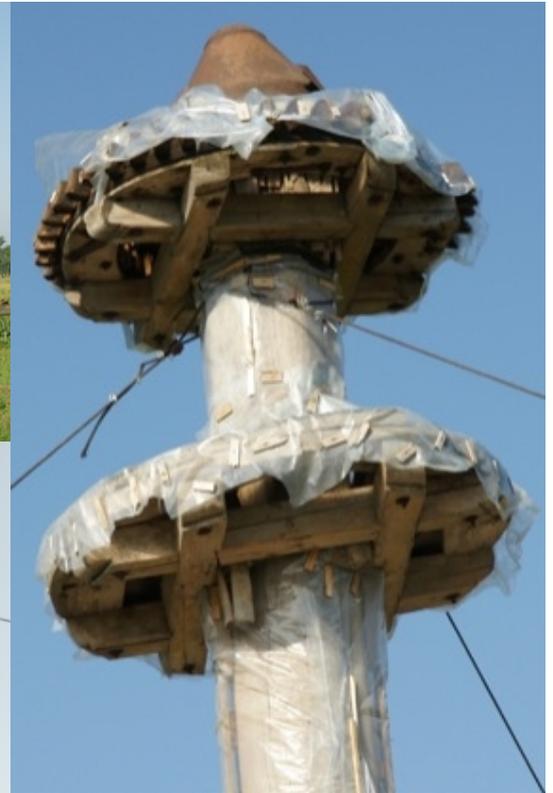
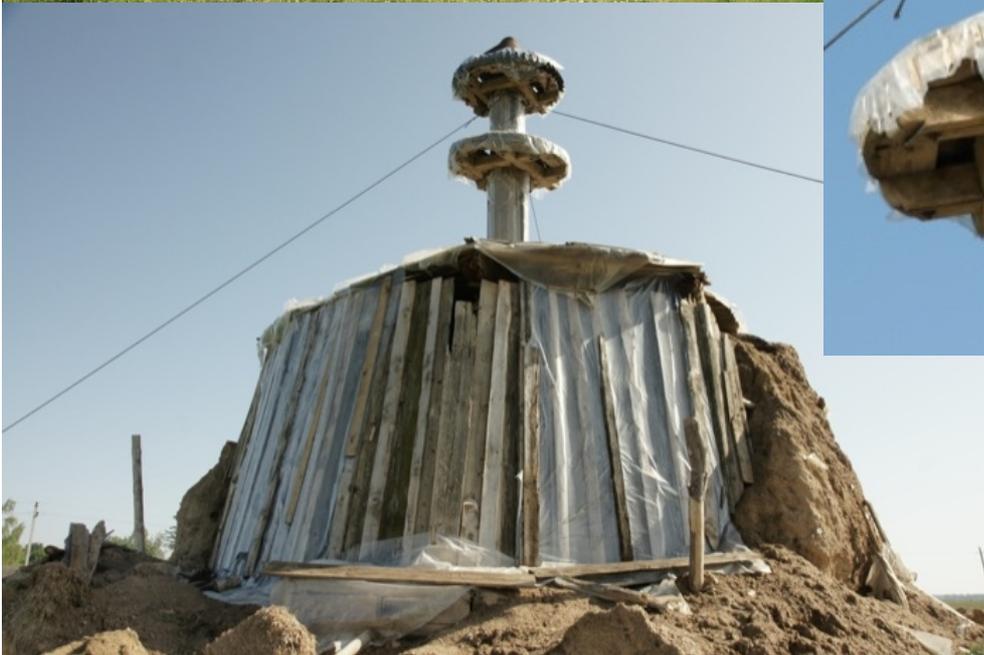
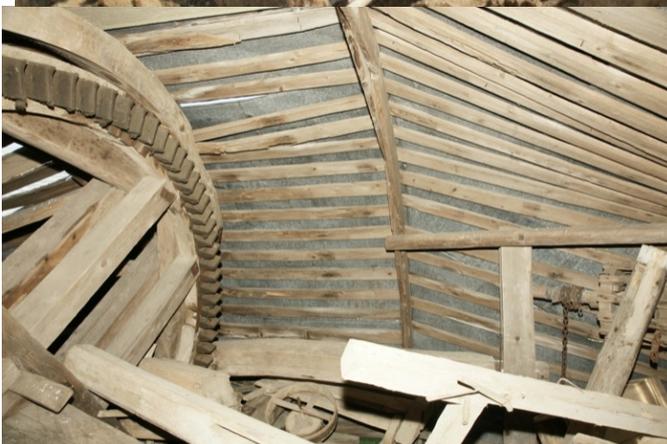
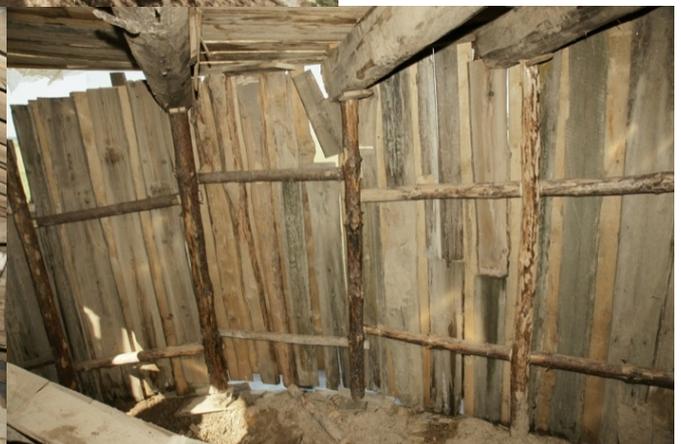
57 Melniai
clay mill, ruins

TIMS mid-term excursion visited this mill in 2003. The TIMS council wrote in 2003 a letter to the President of Lithuania for saving this mill because of its uniqueness. Unfortunately this letter did not help and as we can see now the mill has been partly destroyed. We heard that action will still be taken to repair but actual this is to late and will be expensive!
In TIMS-IM from 2003 no picture is printed of this clay mill.

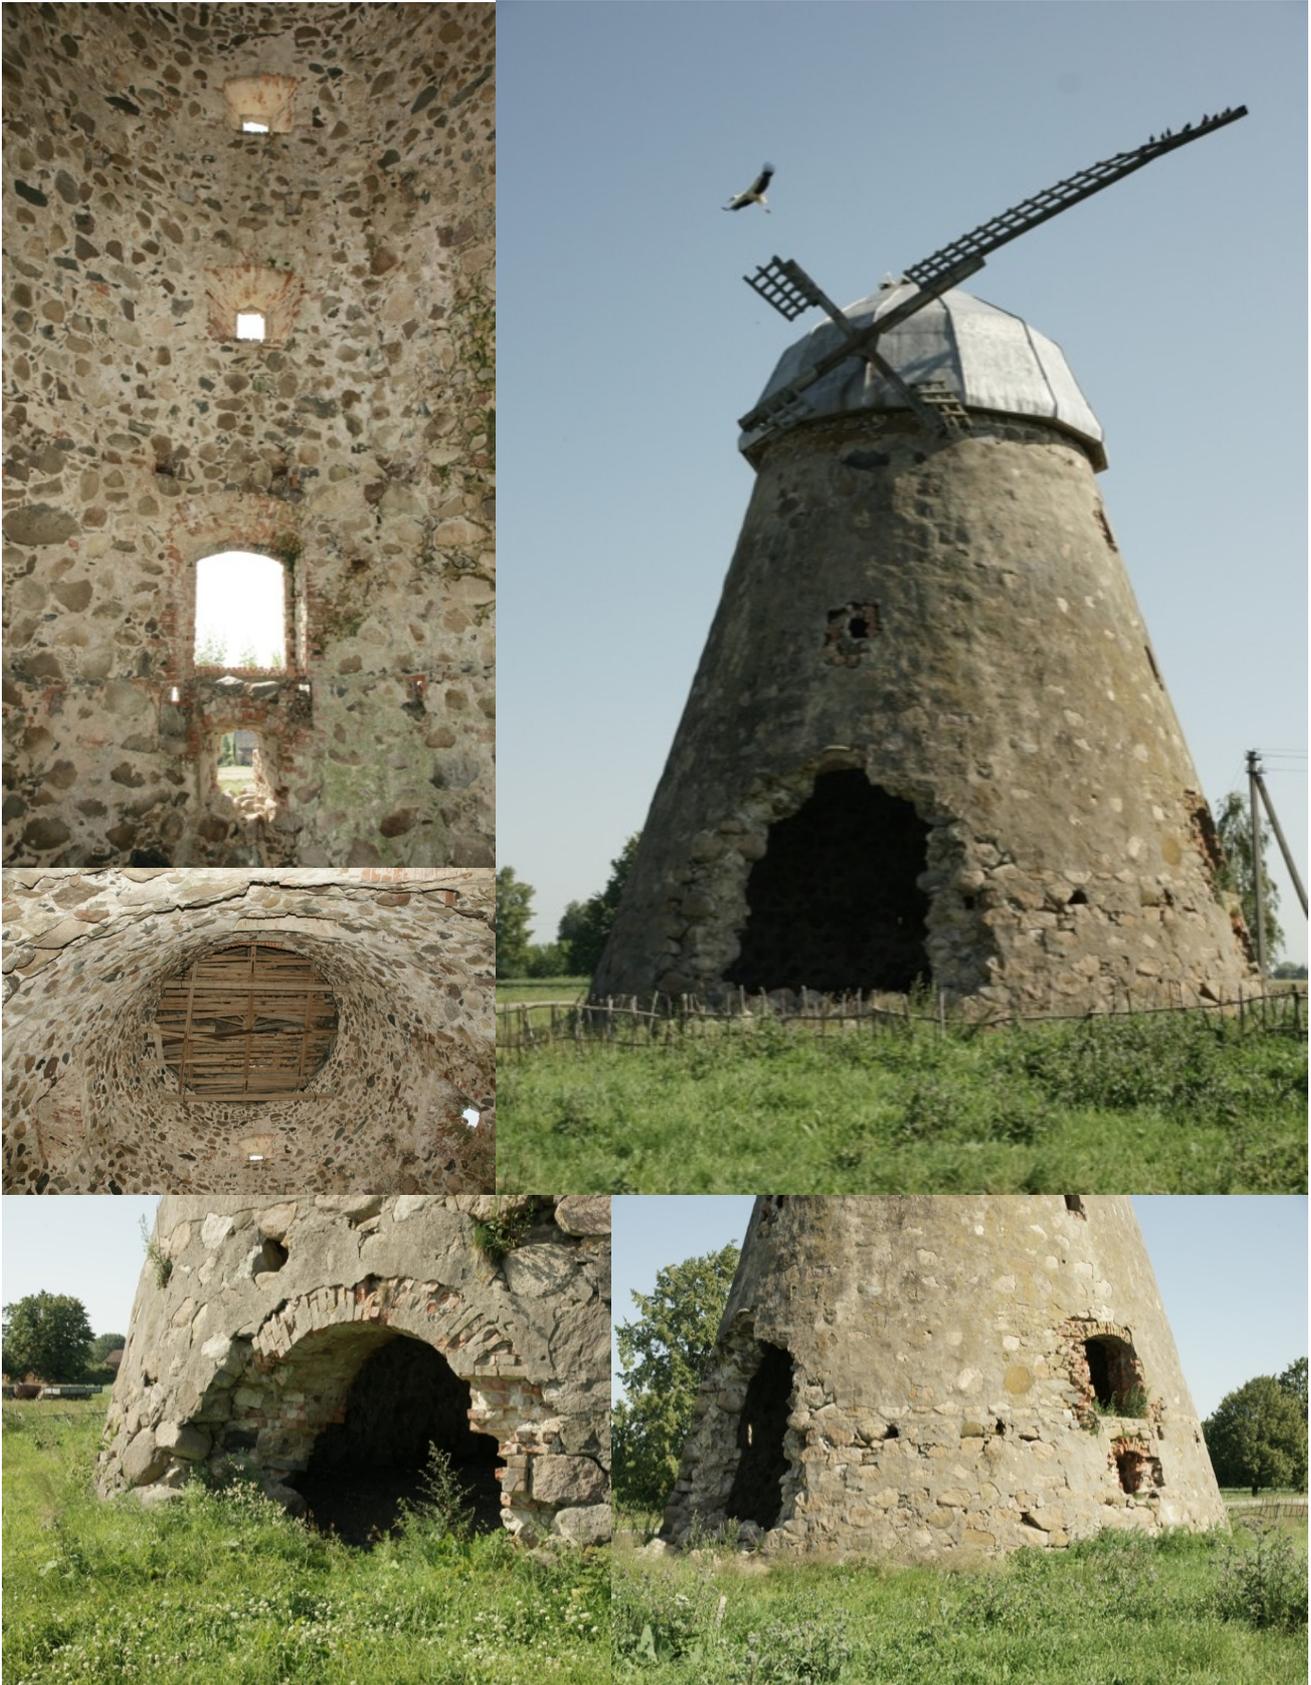
58 Pašvitinys
Windmill

Mill is empty inside. One wing is still OK but the other three have been broken off.

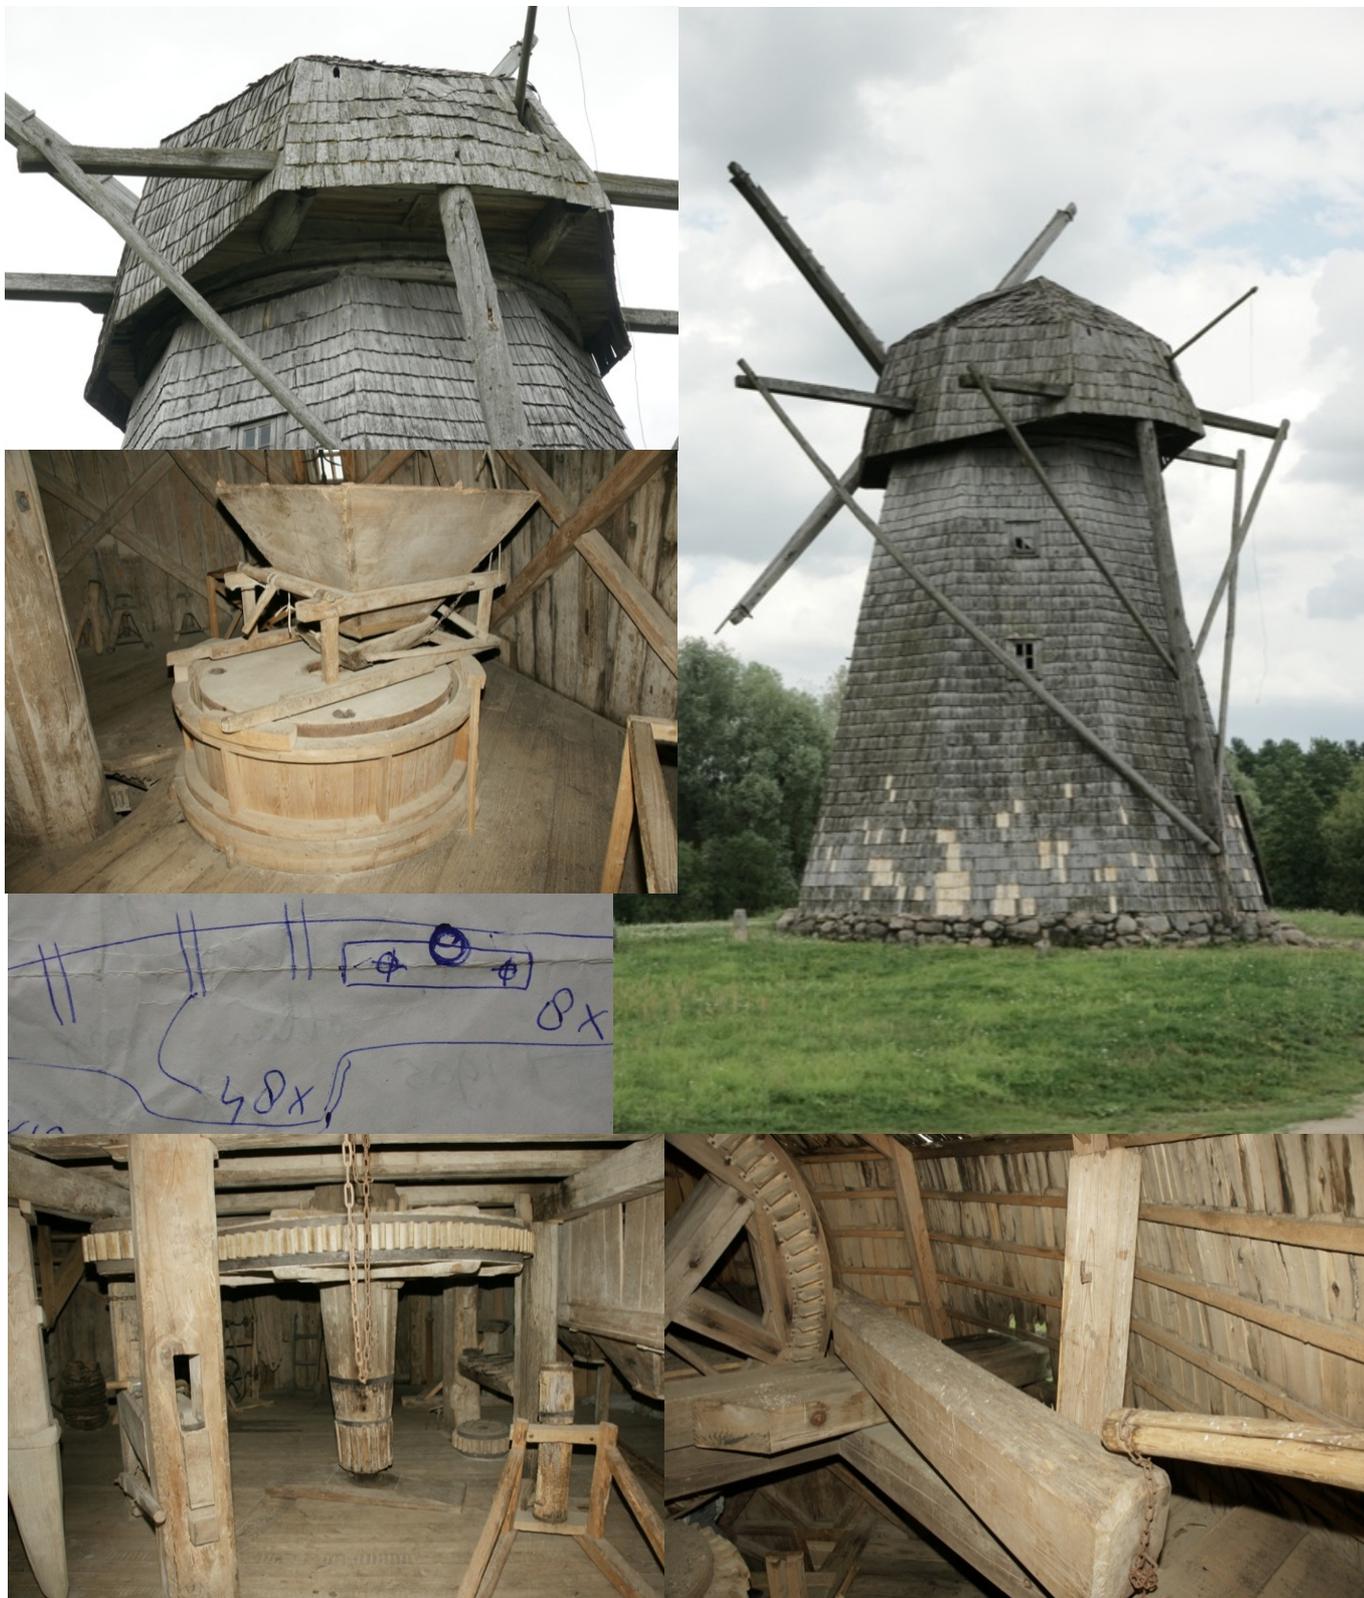
62 Pakalniškiai
Windmill

In 2003 still fully operational, after that one wind shaft broke but will in future be repaired. Interesting cap which is kept in place with 8 horizontal rollers, see picture below.
