70 visited Baltic mills in 2009
1 page per mill

Tour in July 2009 to 70 Baltic Mills in Saaremaa, Estonia, Latvia and Lithuania

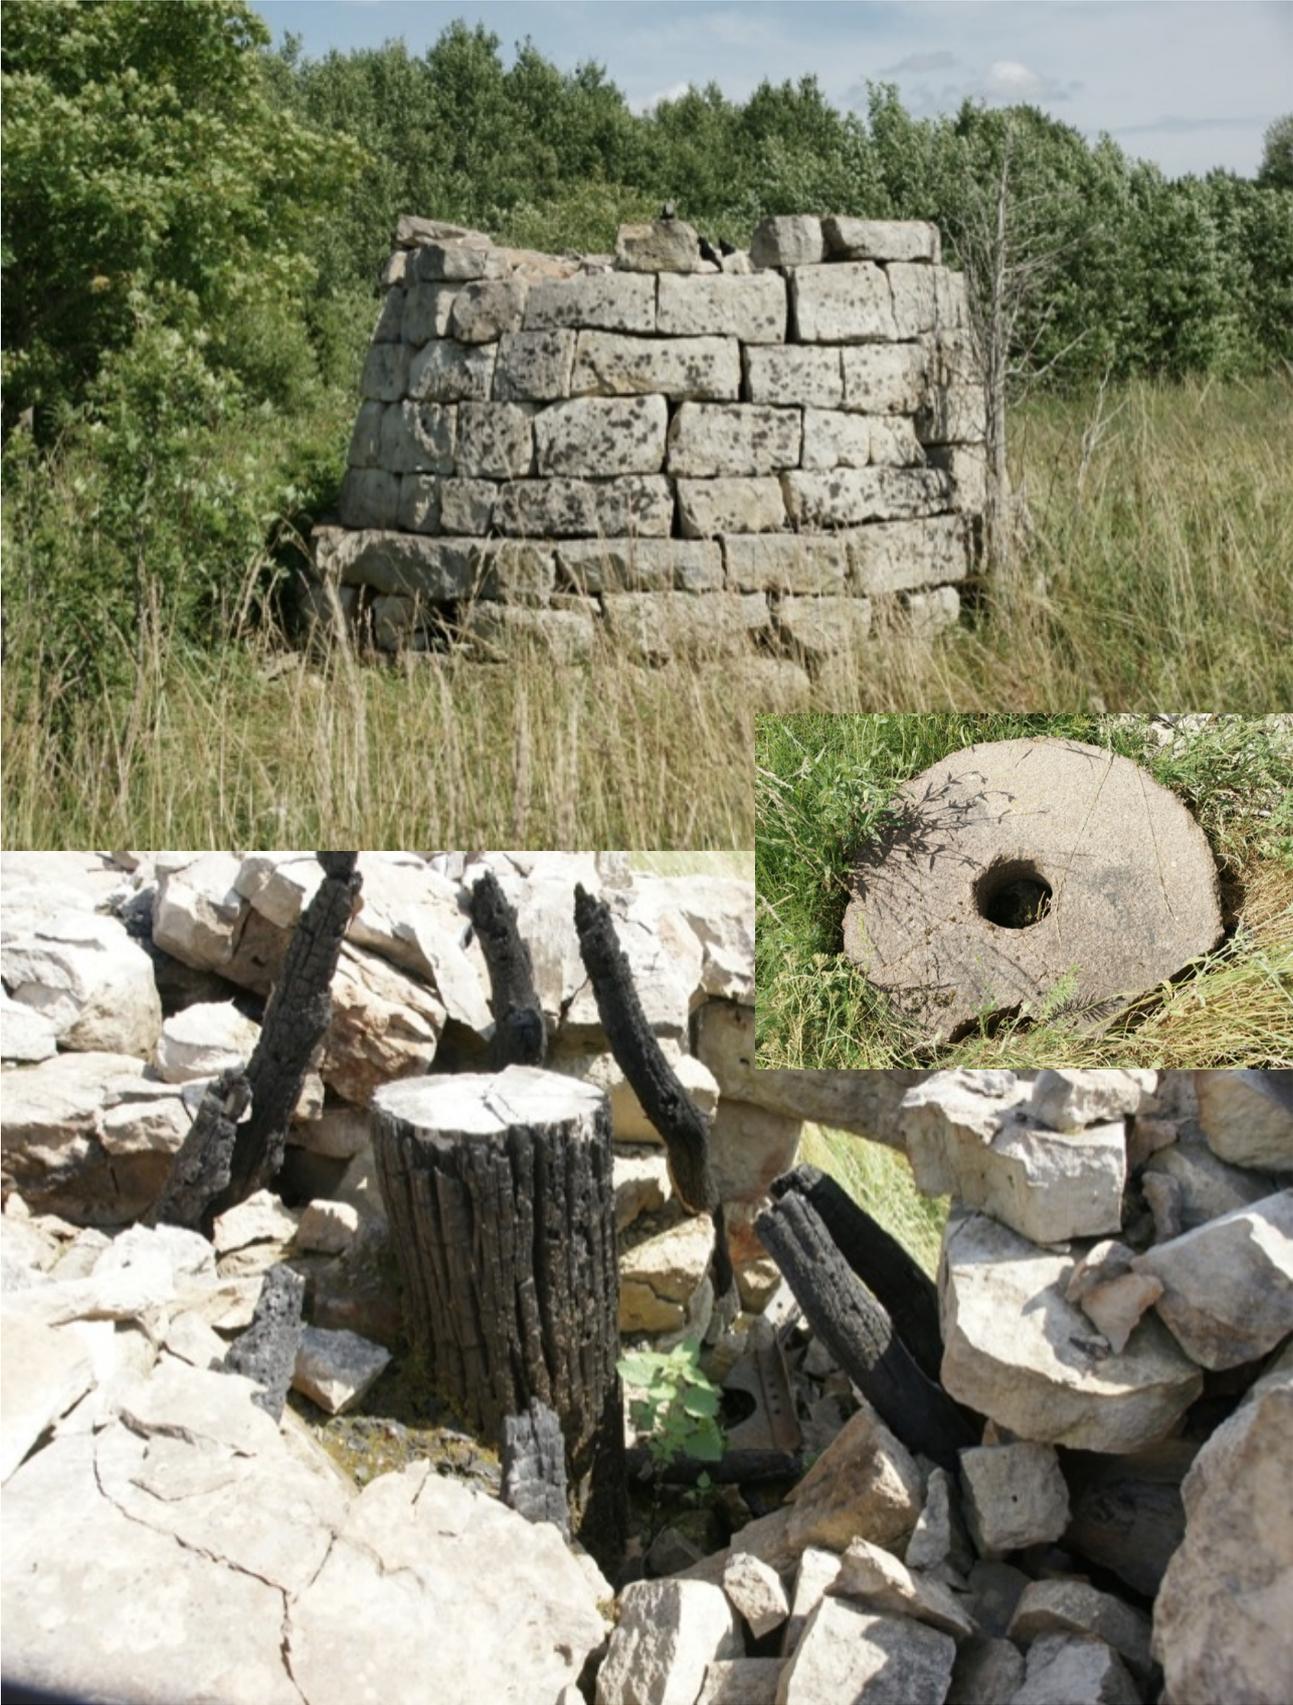
15 Kõruse1
Windmill, ruins

Very old, +- 17xx, wooden bearing. 1945 in wood.

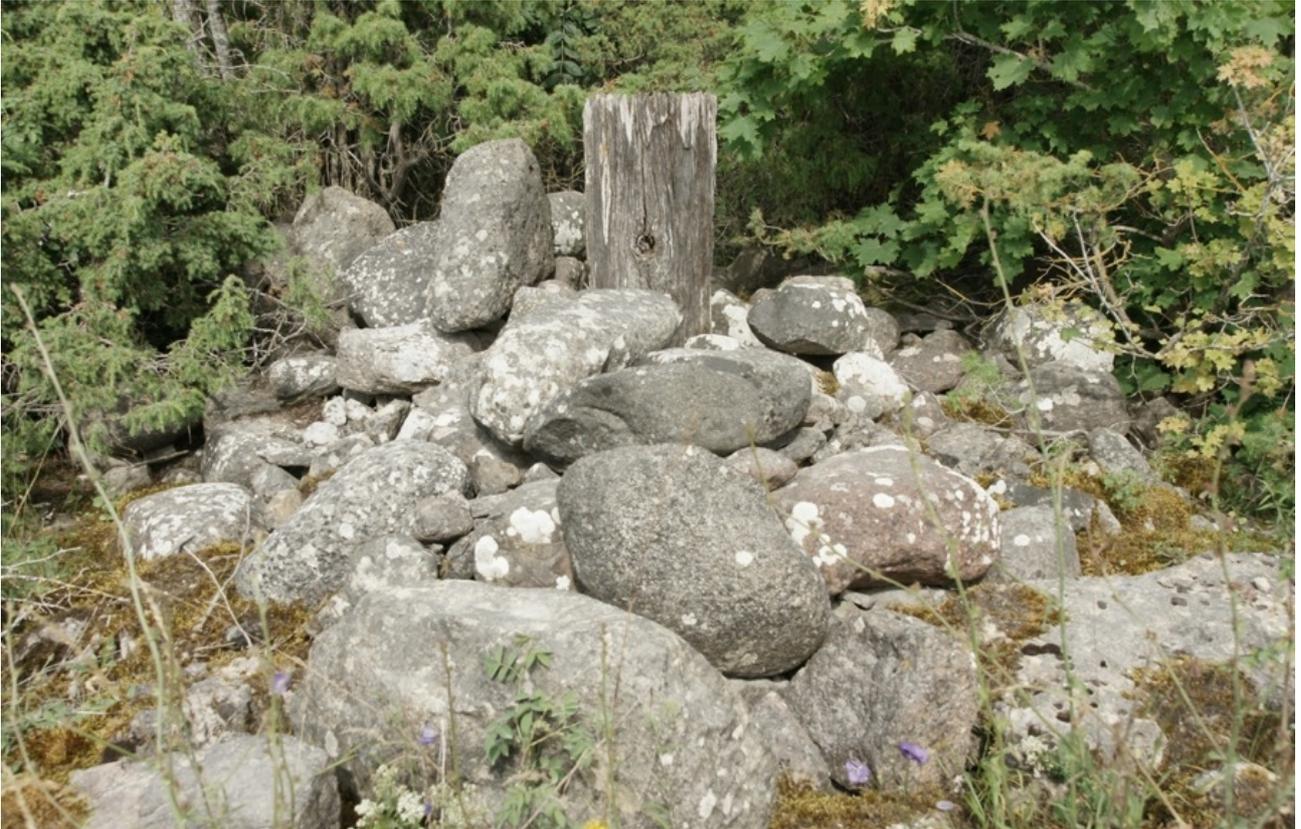
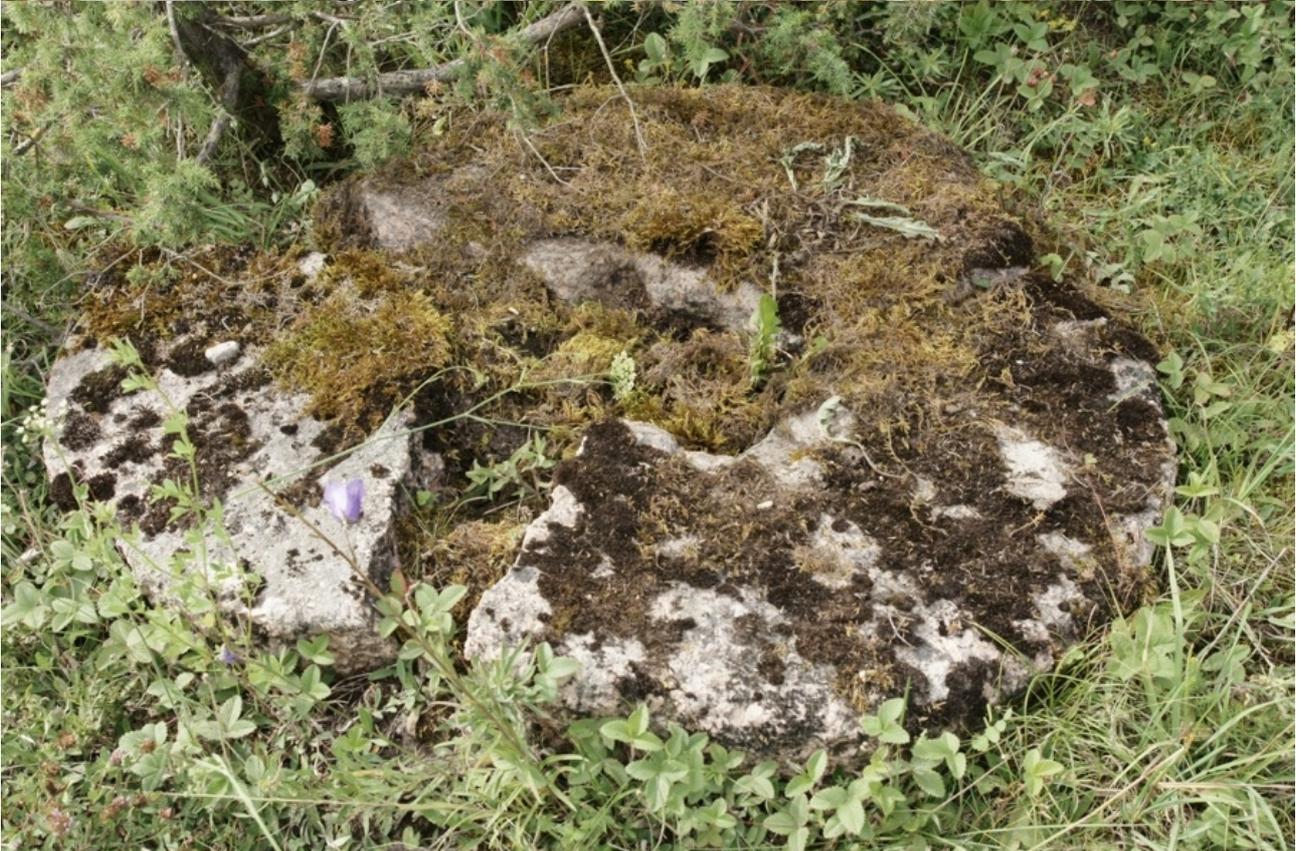
17 Kõruse3
Windmill, ruins

including broken millstone behind the tree.

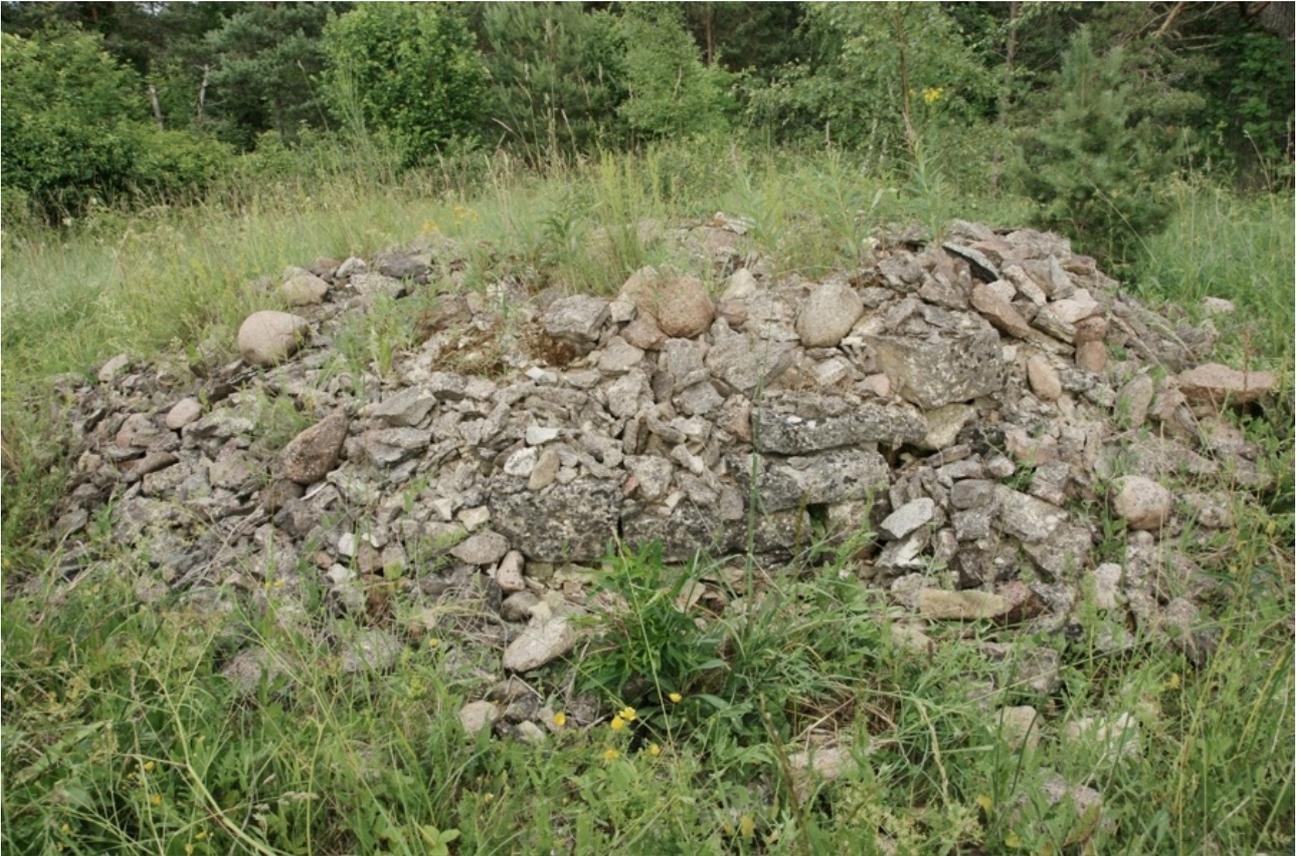
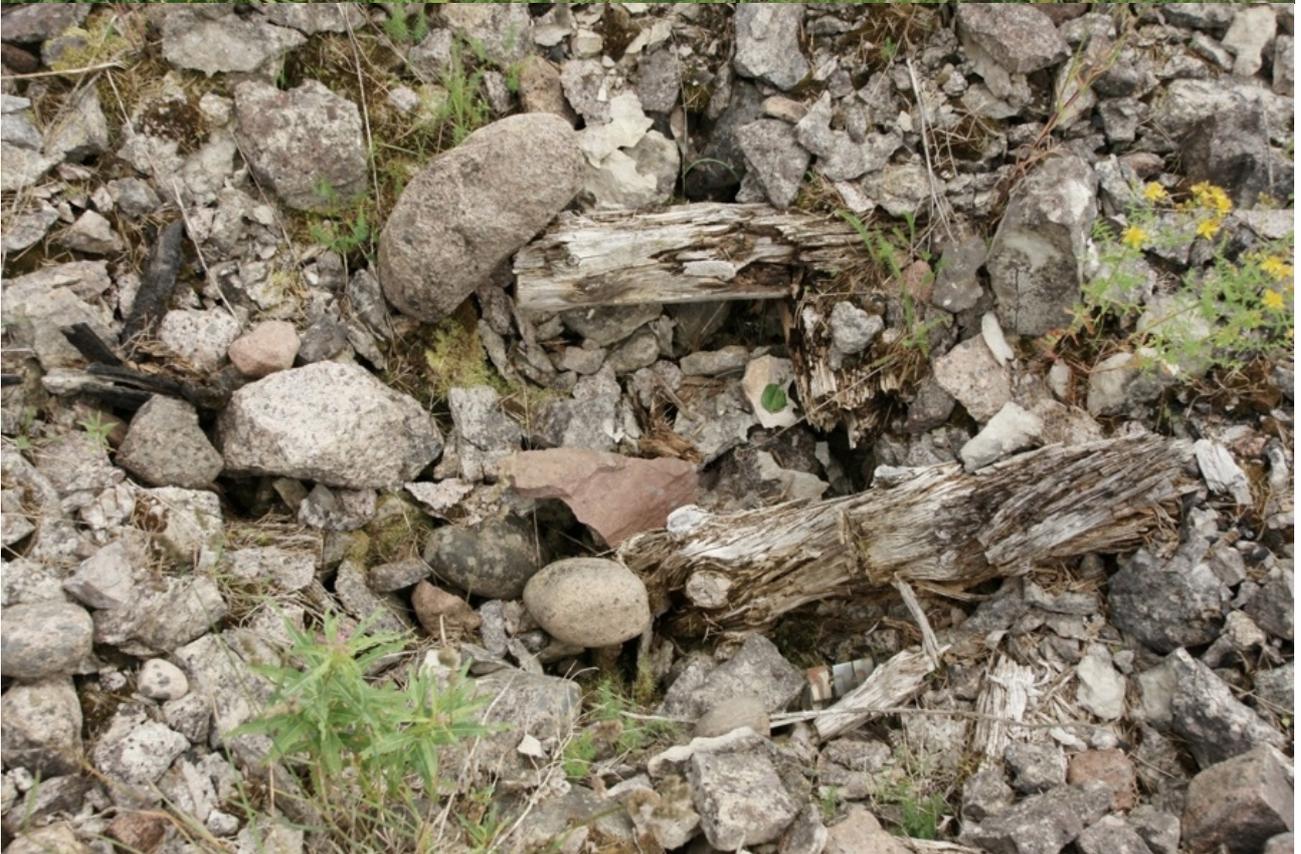
21 Viki
Windmill, ruins

Burned down in the beginning of 1990 ties.

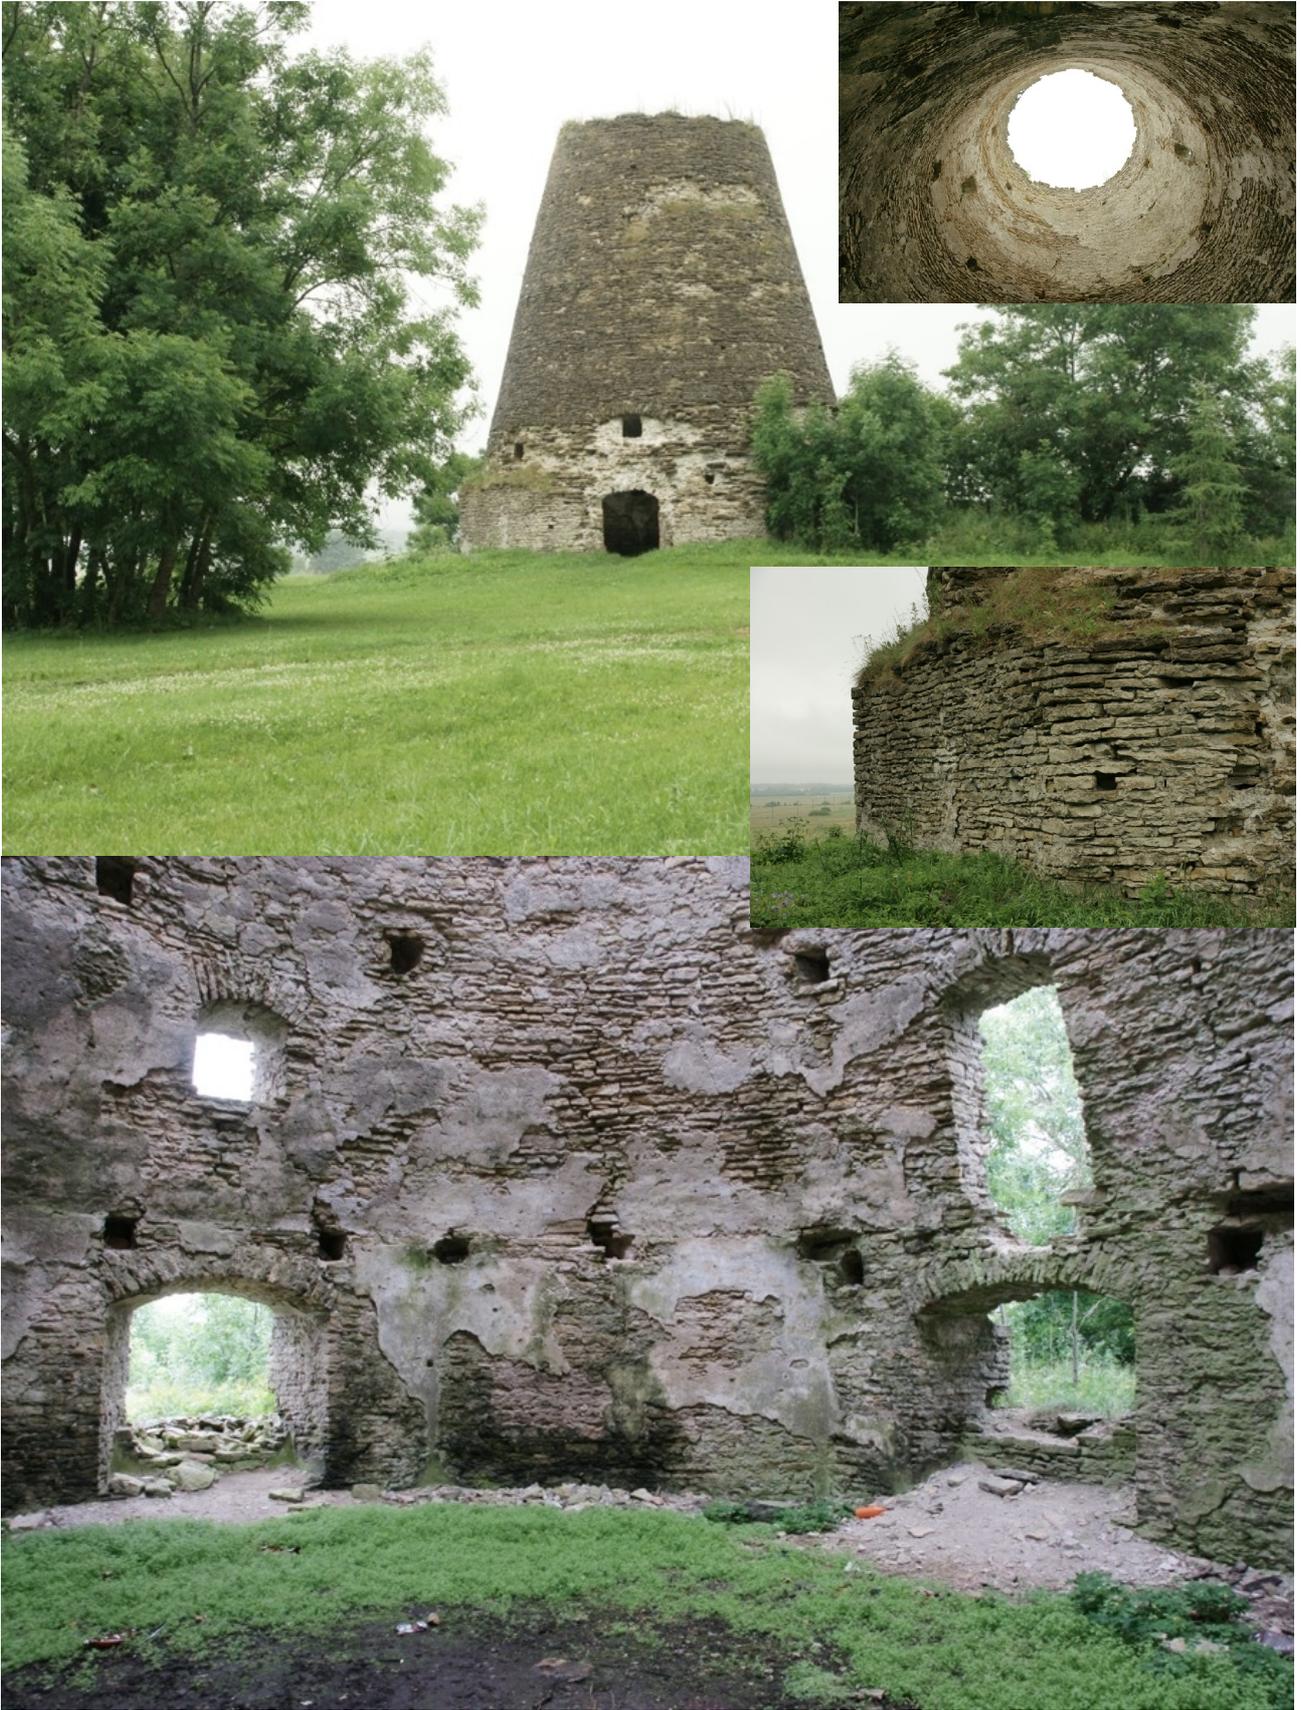
26 Ellemaa

Working until 1928, after that a steam mill was used in the city of Ellemaa. Mill was turned by hand or horse. Three anchor posts are still located at ground. European Union restoration project. Mill is complete inside. Key can be obtained by owner of farm.

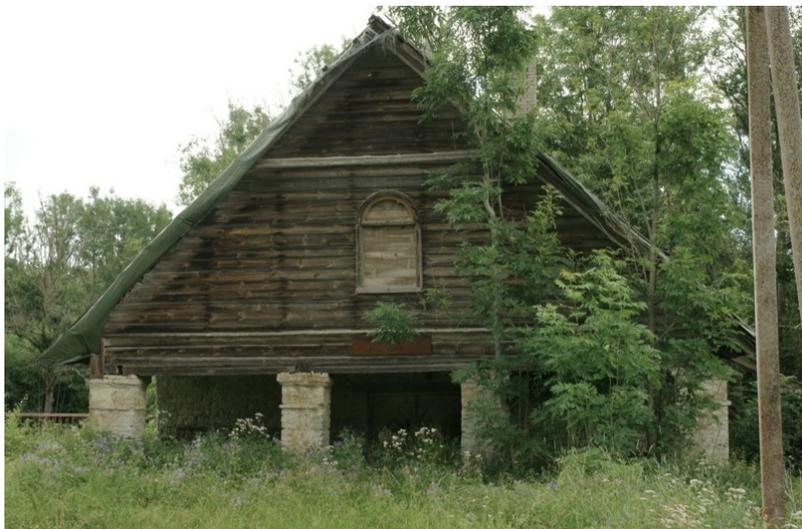
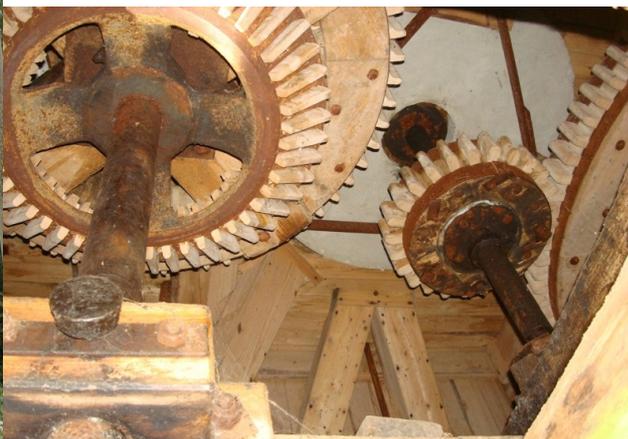
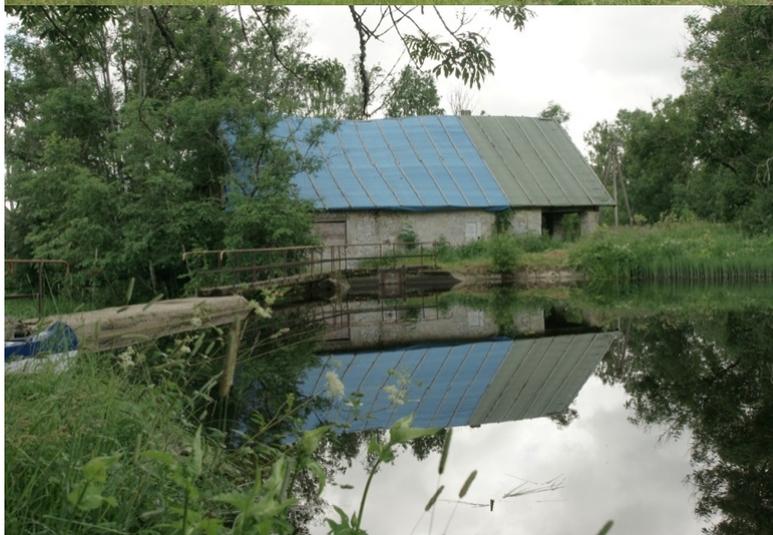
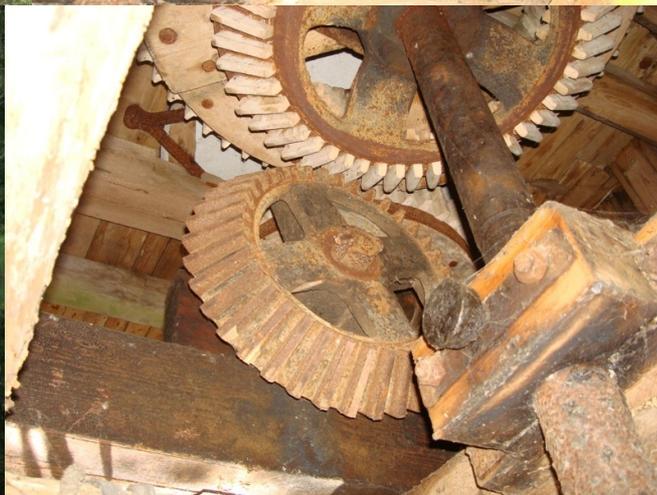
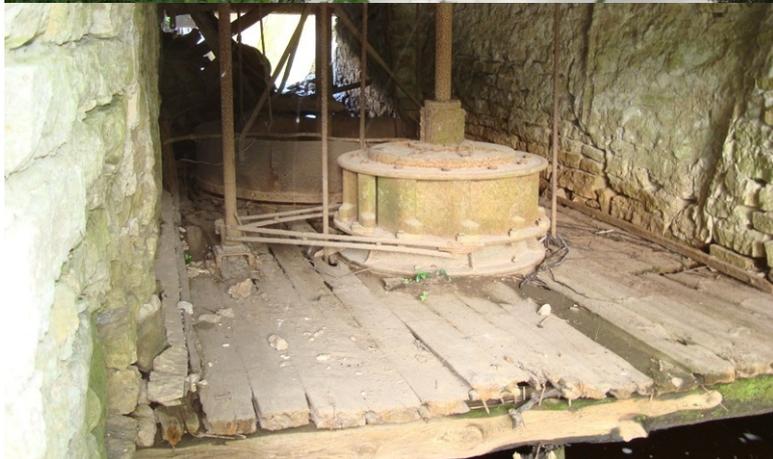
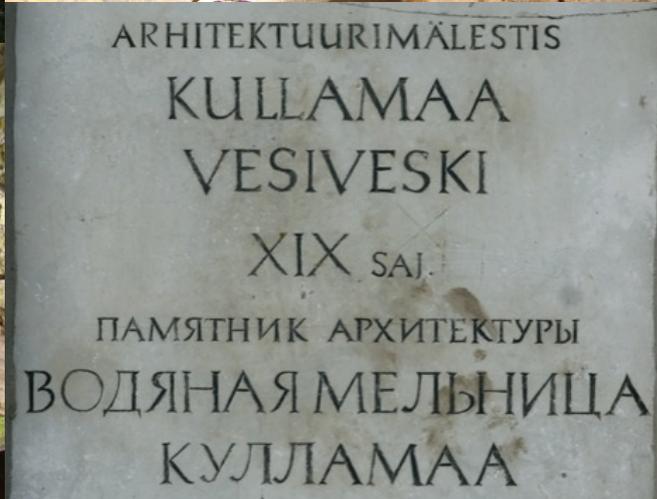
28 Kullamaa
Watermill, turbine 13

Quite unusual watermill similar to the one we've seen at Pidula. Owned by rather wealthy local person however no efforts have been made to preserve the building. No idea what's inside.

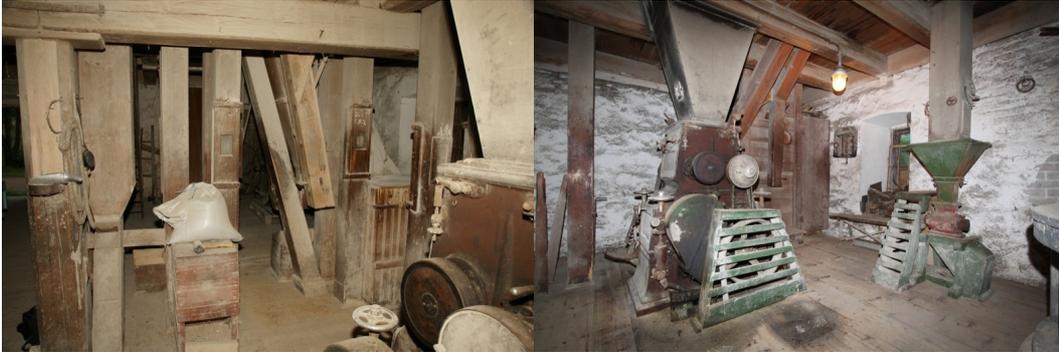
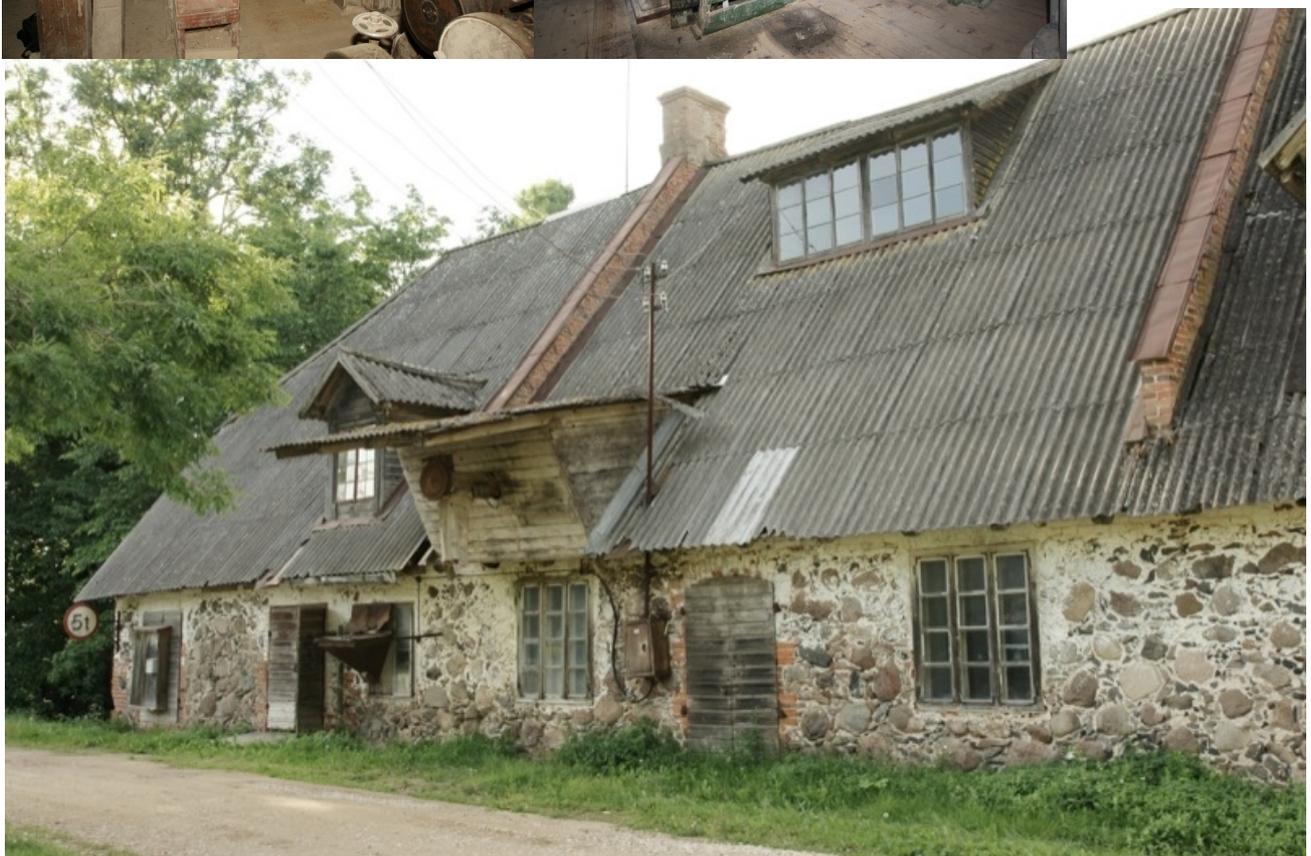
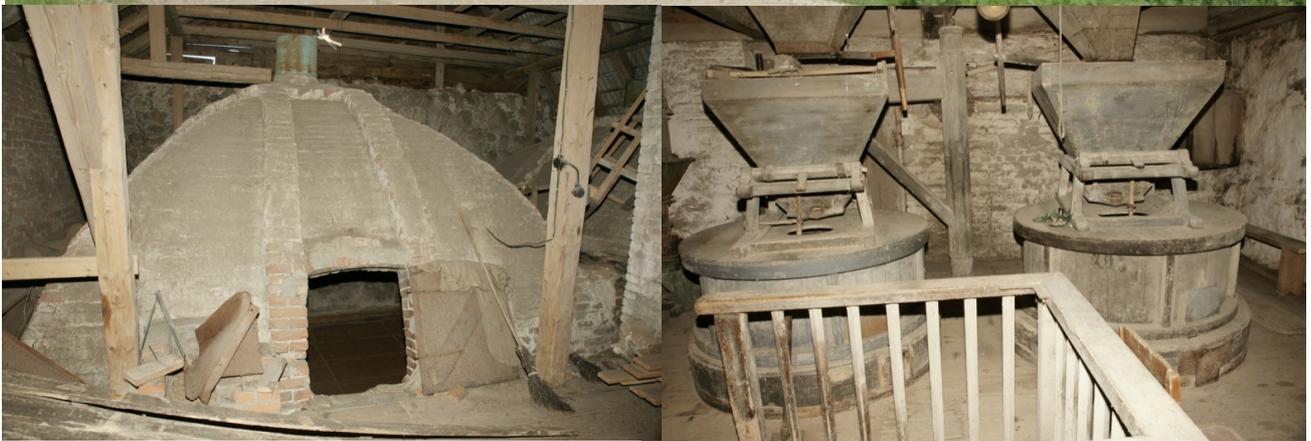
30 Lahmuse
Watermill, turbine 13

Intact, some renovation works going on, meeting with owners can be arranged.

Build in 1860. Nice watermill with much machinery and two big ovens for drying grain, location is inside the building at the far right end of the building!!

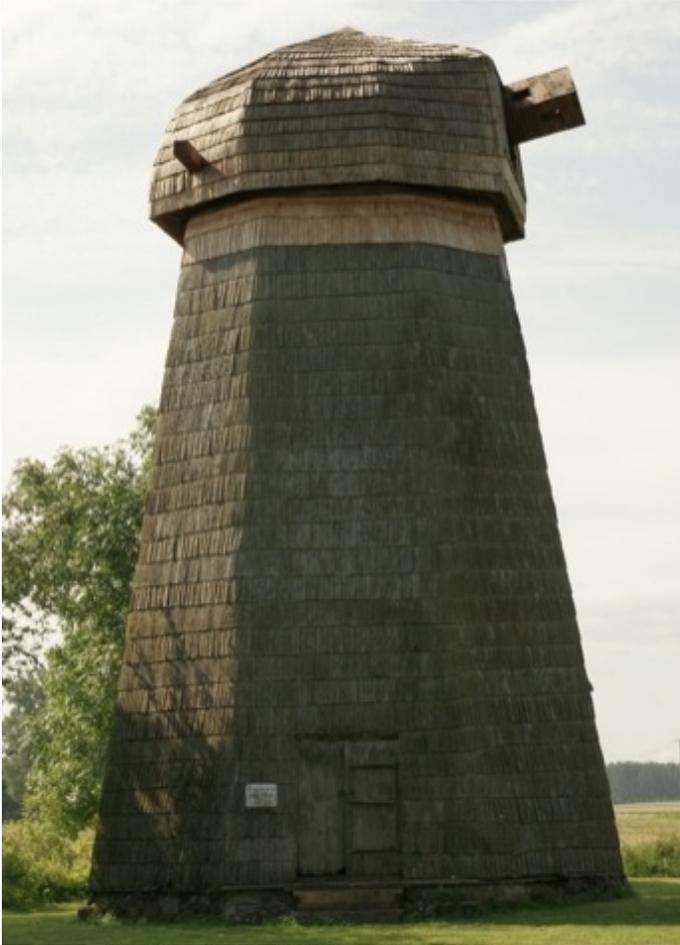
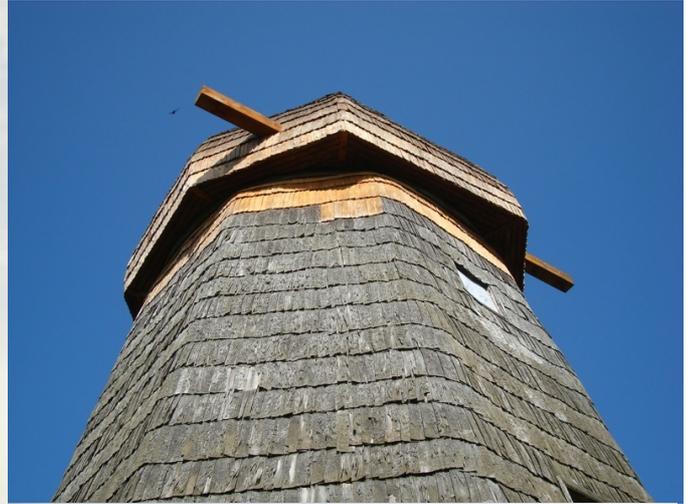
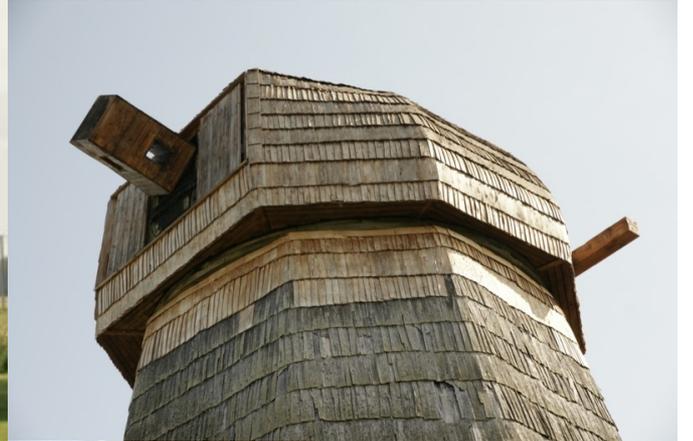
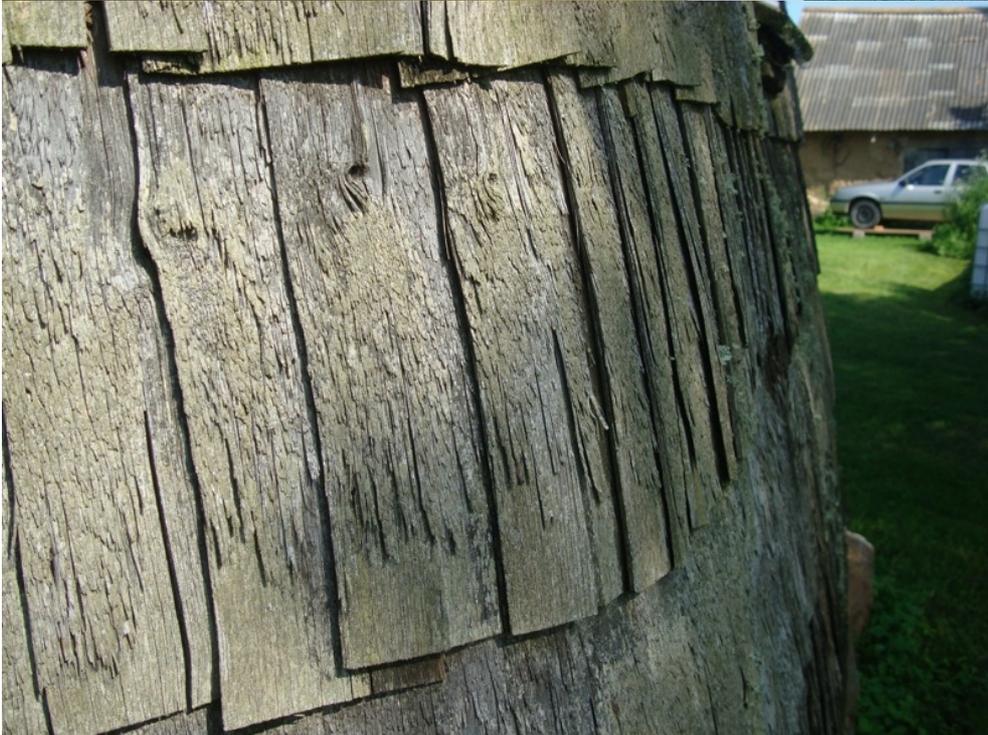
Estonia-Mainland N:58-16-23 E:26-08-23
14

The mill is currently not in working order as the turbine shaft was damaged last year by accident. Some renovation works have been done since you were there: the mill has a new shingle roof and general maintenance works have been carried out by volunteers. Build in 1880.

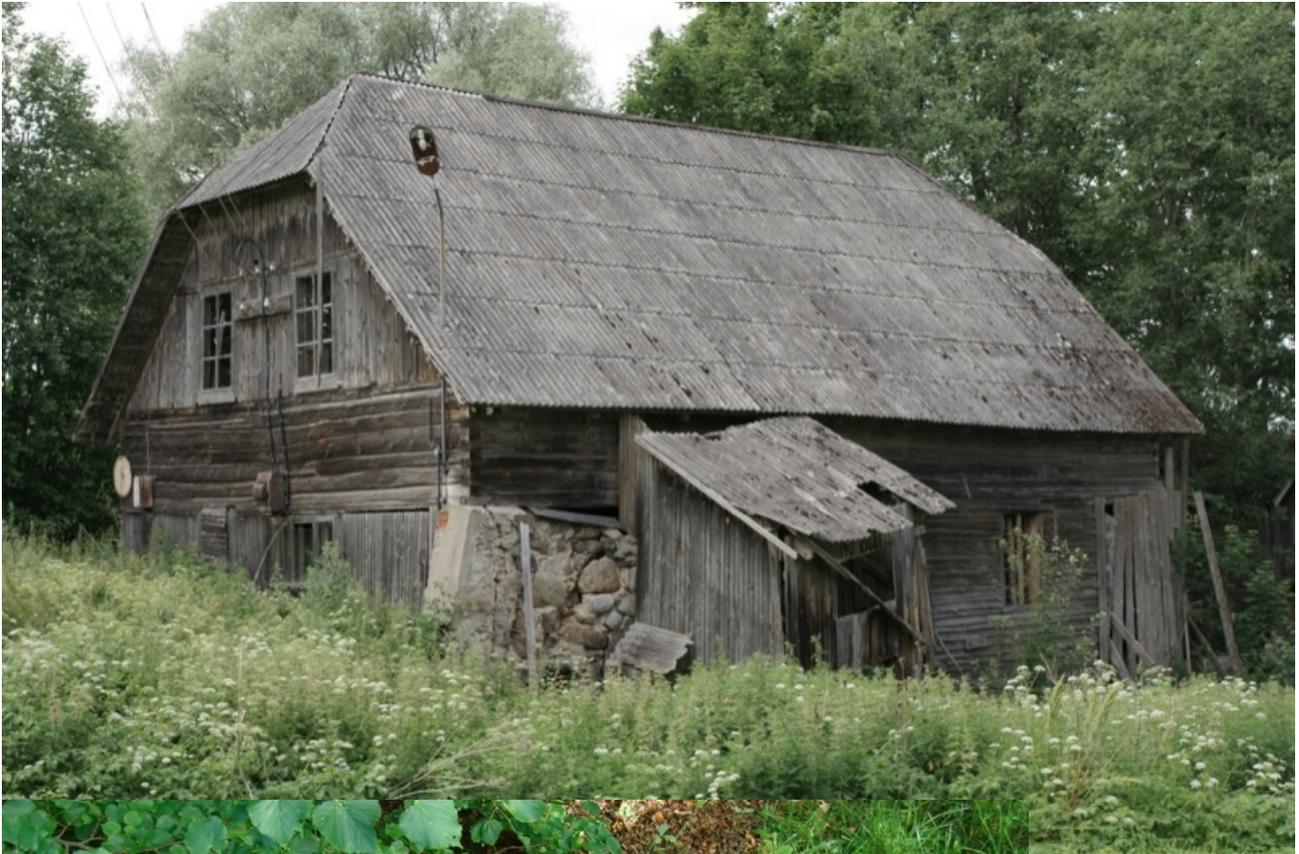
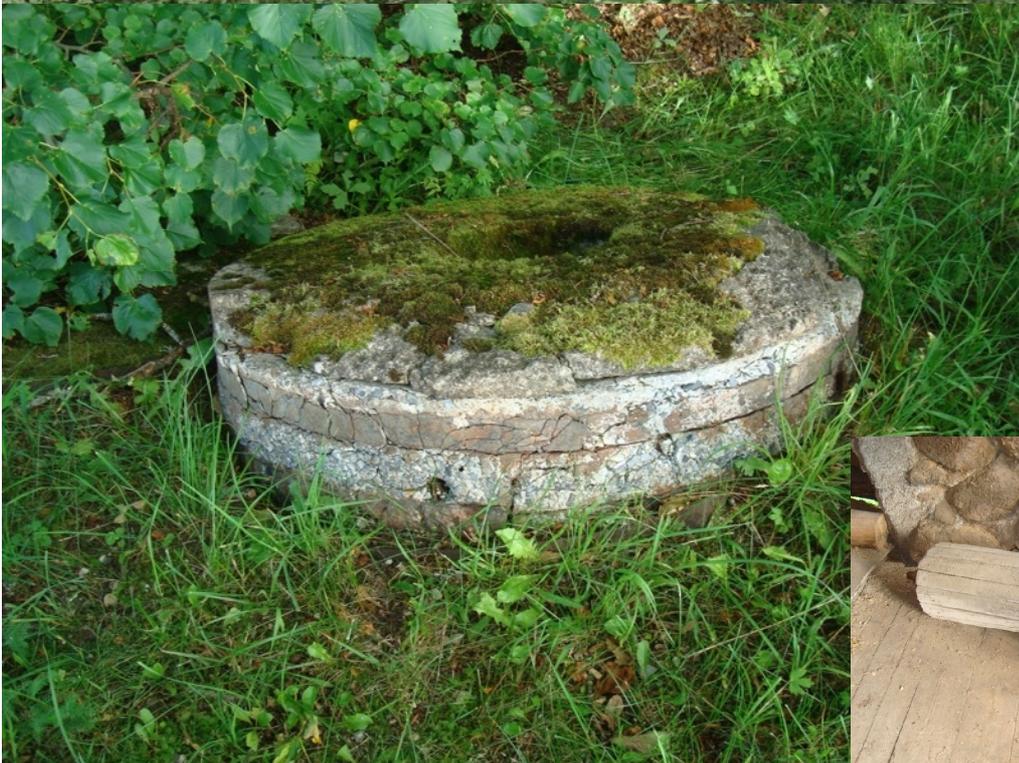
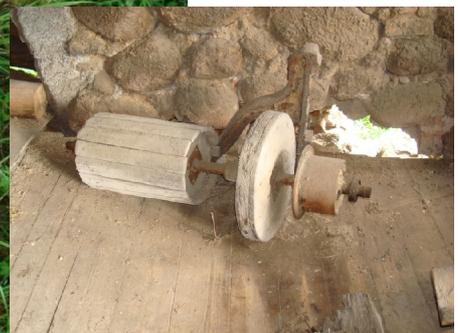
36 Illi
Watermill

Small watermill from 19th c., typical to Southern Estonia, in poor shape however machinery partly intact. On sale (for 30700 EUR) <http://register.muinas.ee/?menuID=monument&action=view&id=14129>

Dead rat was found in mill. Door can be made open but inside there is another door locked to the rest of the mill.

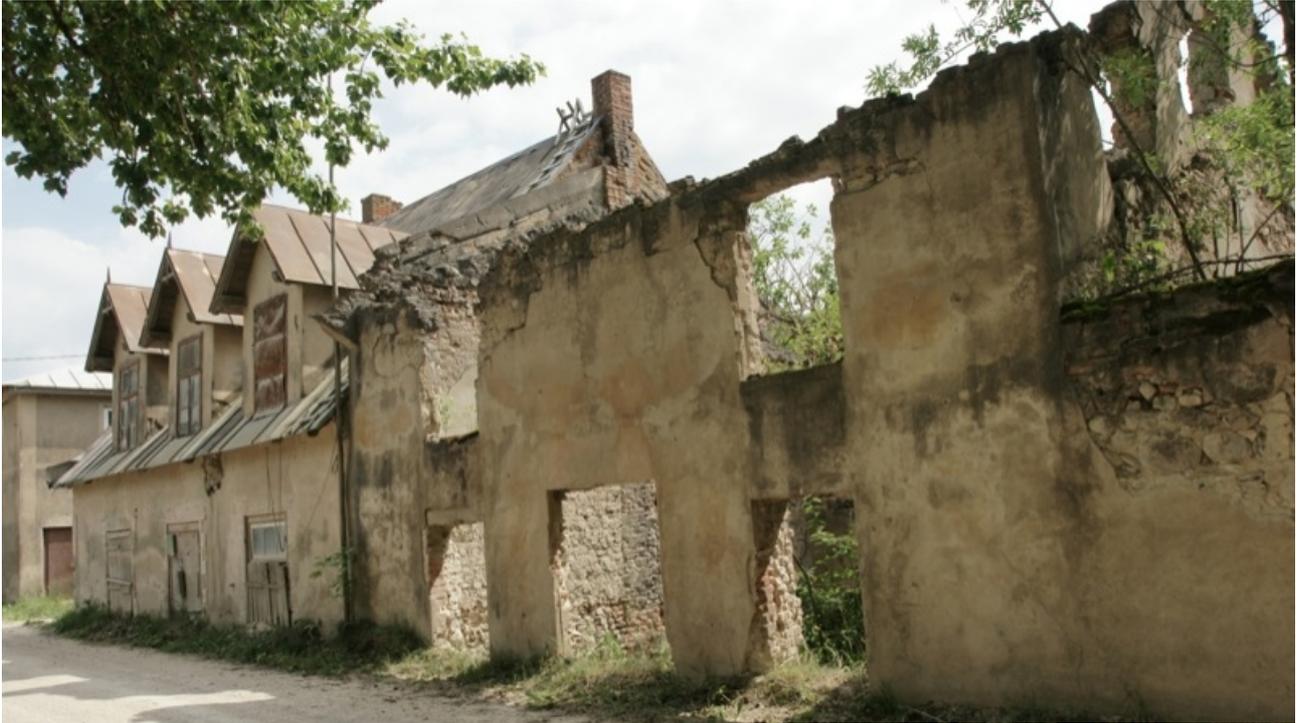
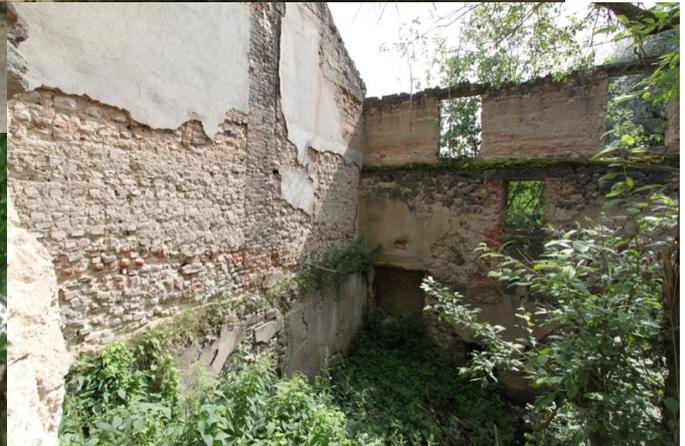
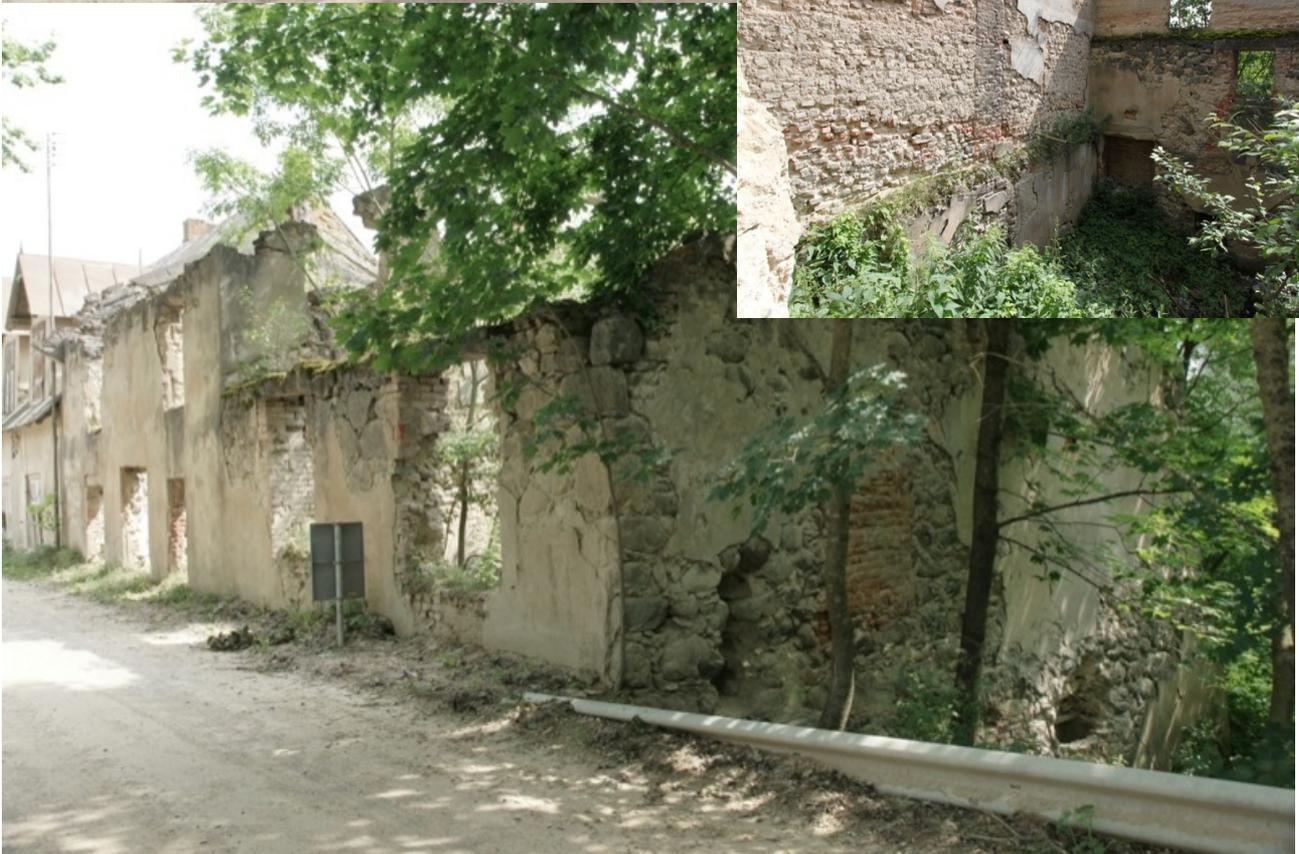
41 Siljāni (Recijas) Latvia N:56-44-18 E:25-34-41
Watermill, ruins 15 Maybe only hole for wateraxis

No part are left, only hole in wall for scoop wheel shaft.

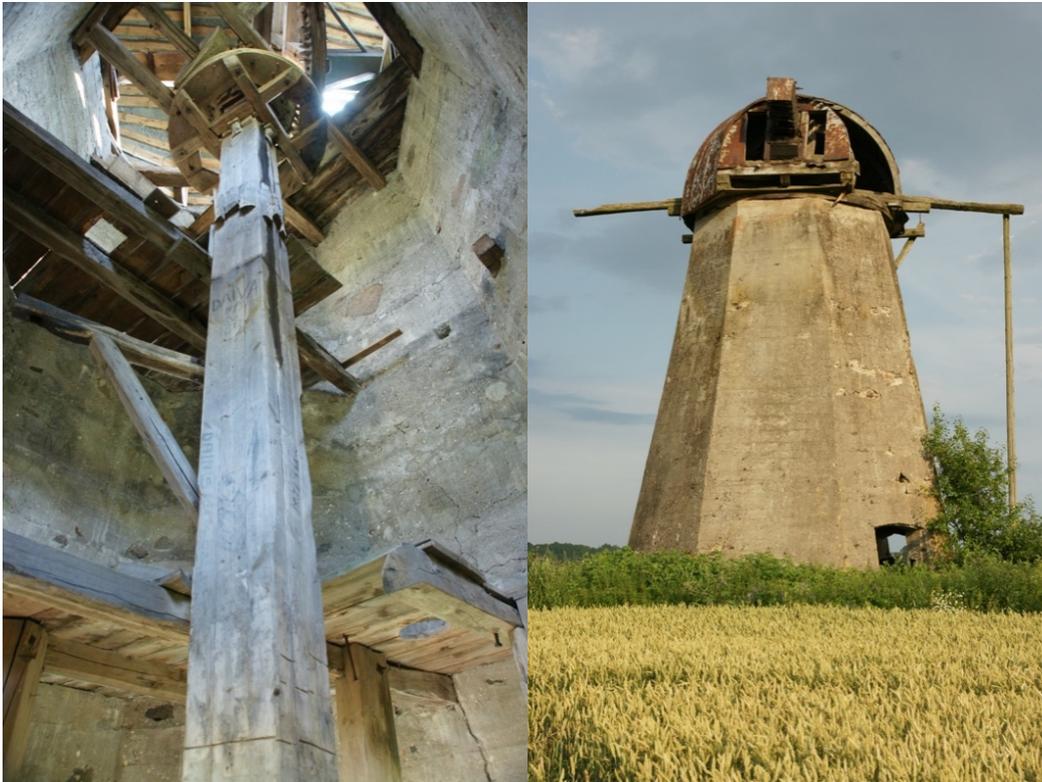
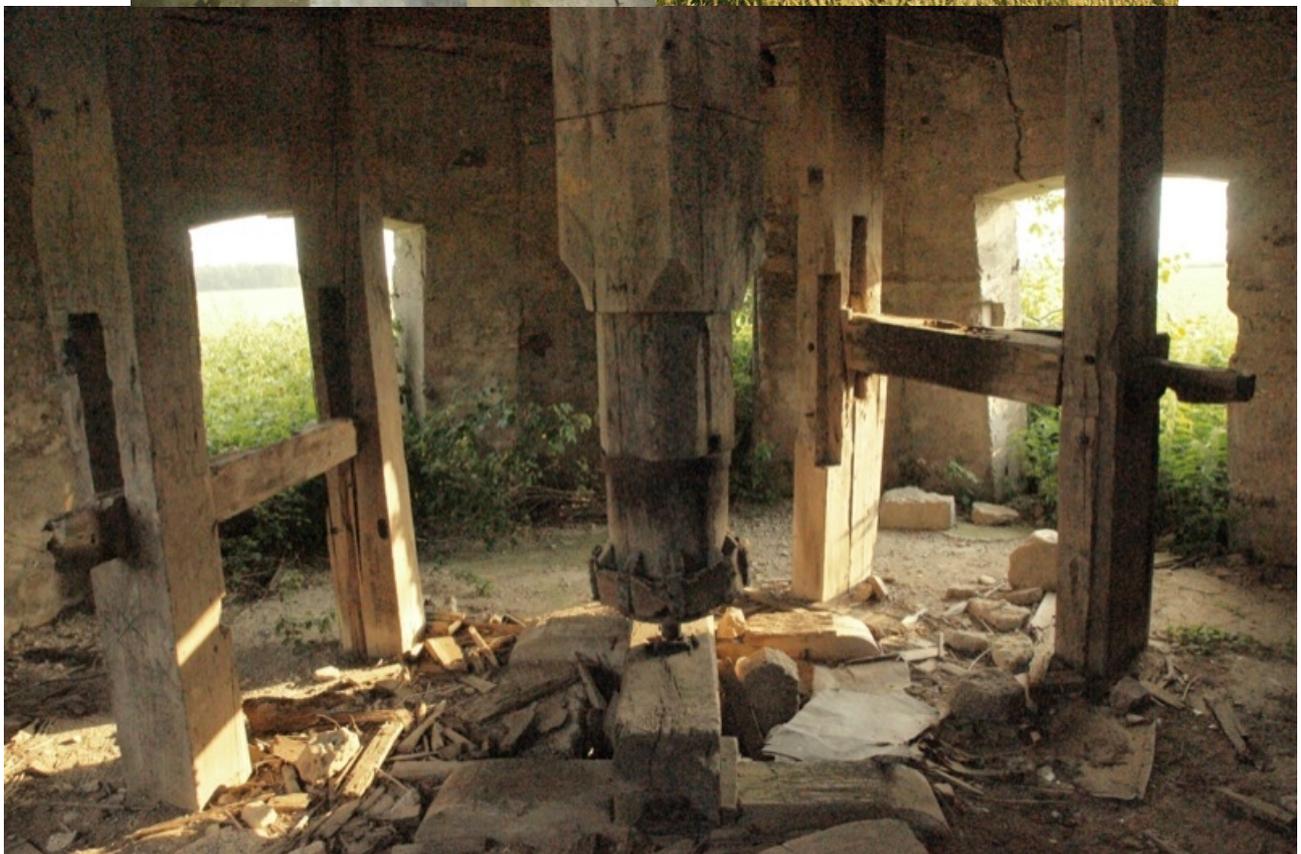
43 Pasvalys, Čižiškiai Lithuania
Windmill, concrete 15 Concrete mill

Octagonal, probably built in 1930-1940.
Some remains are left inside at ground and high in cap. No stairs
anymore.
