70 visited Baltic mills in 2009
1 page per mill

Tour in July 2009 to 70 Baltic Mills in Saaremaa, Estonia, Latvia and Lithuania

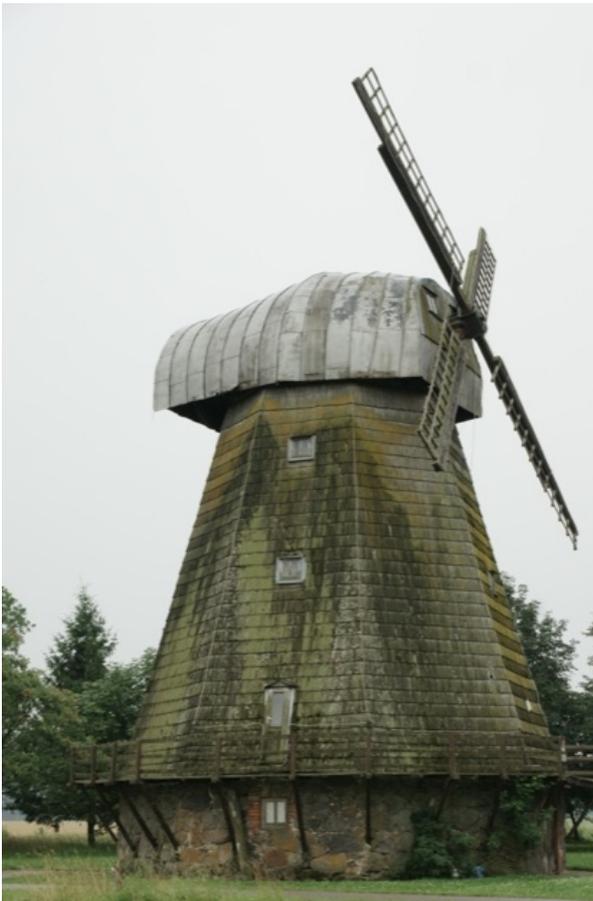
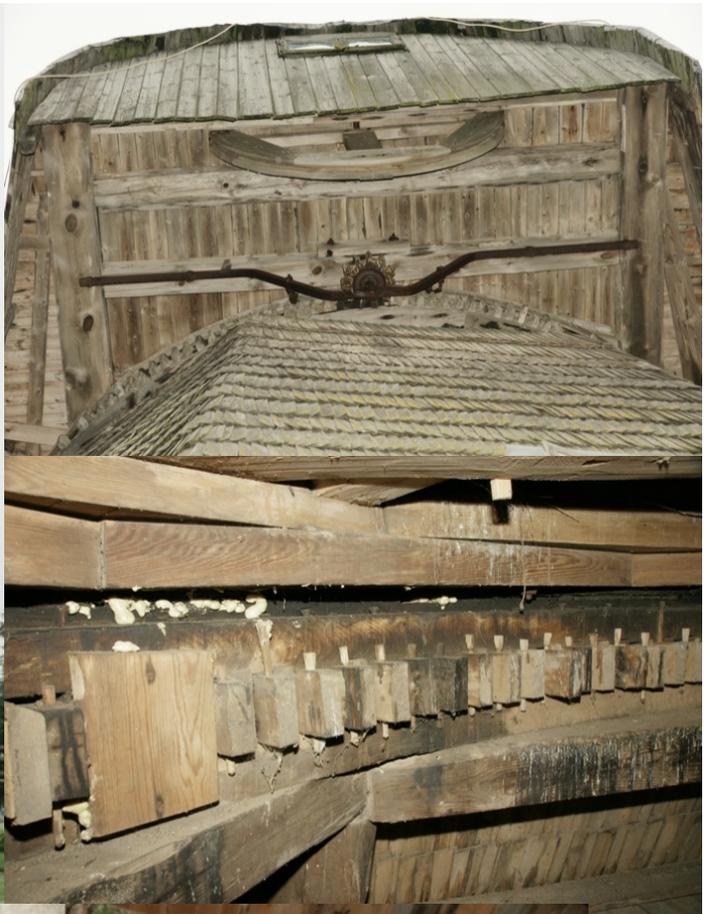
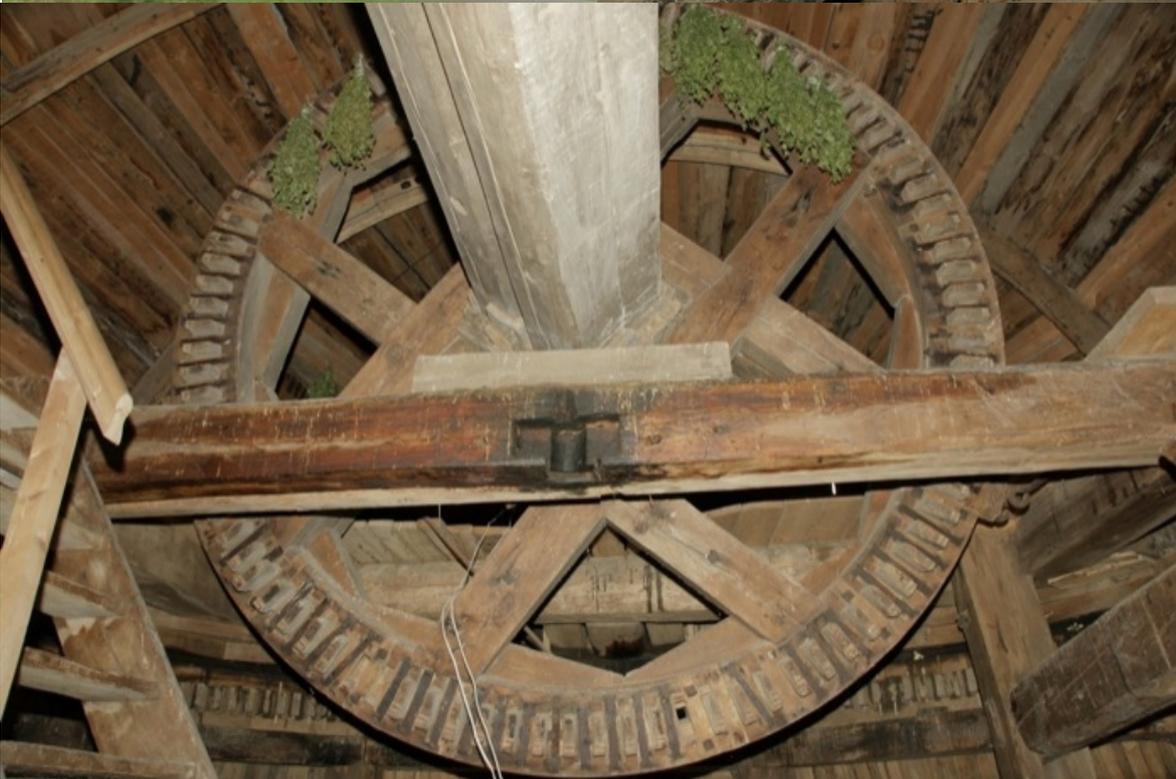
48 Stultiškiai
Windmill

Corn mill, inside is also a flax industry museum. Mill is complete.

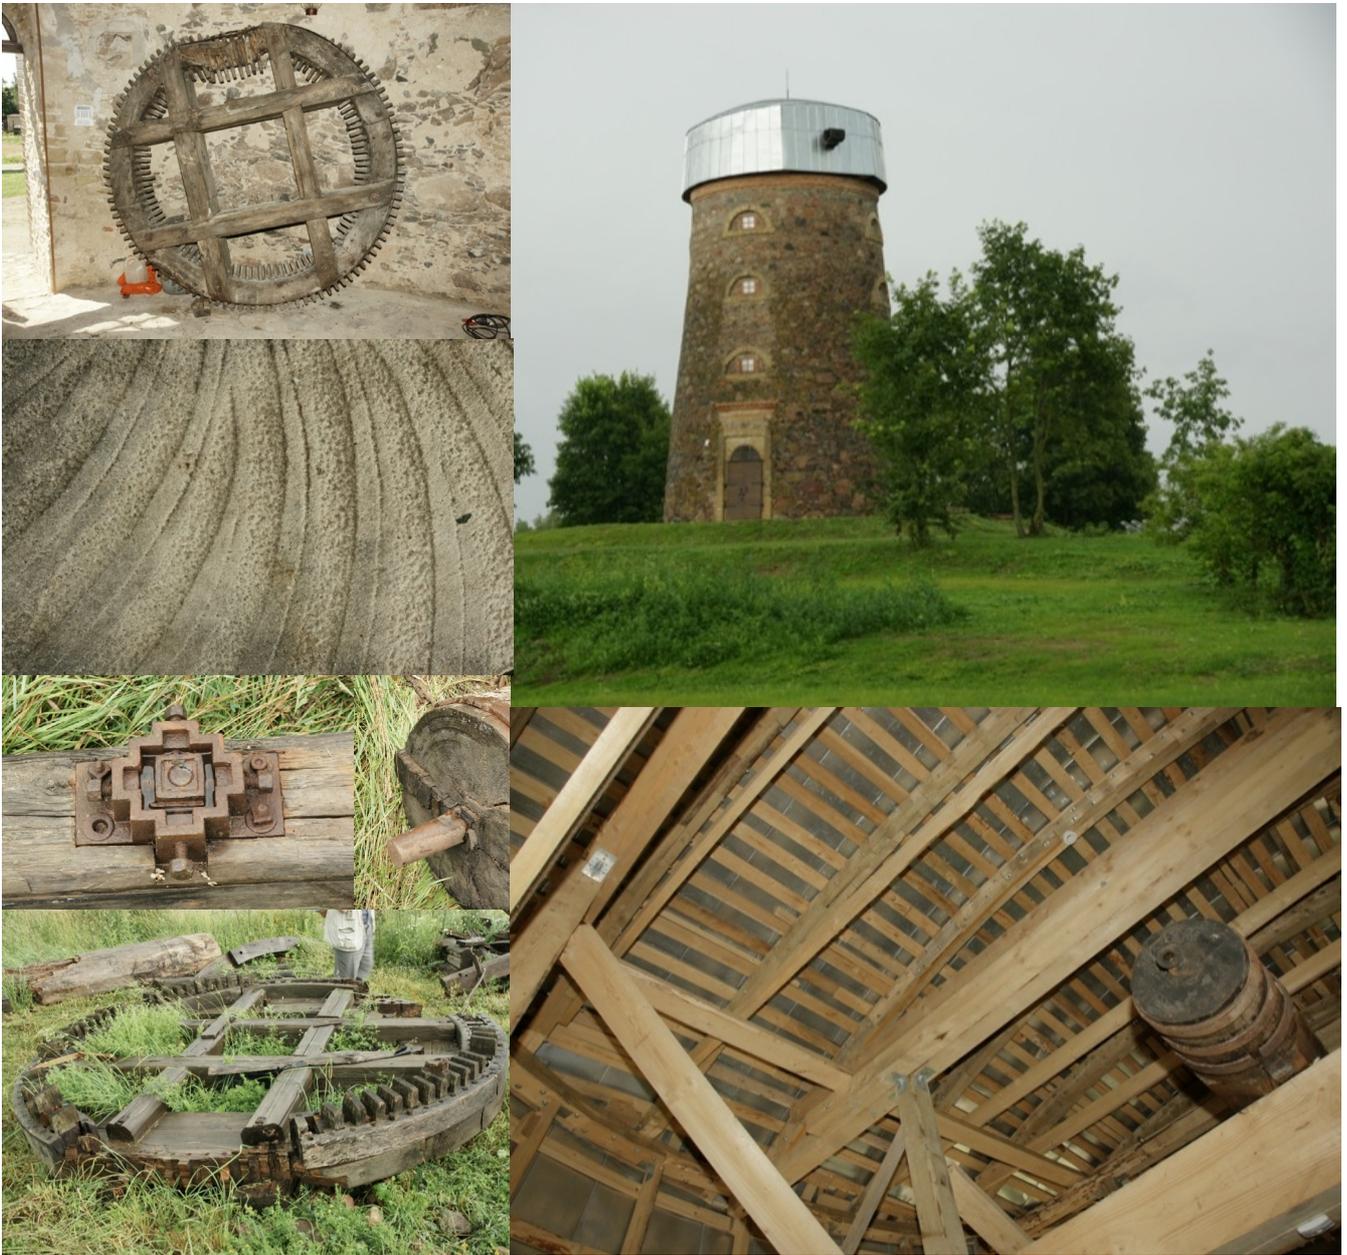
Mill 49, 50 and 51 are at the same location. A lot of mill parts were located aside the windmill. They should have been used for rebuilding the windmill which did not happen. After some years they will be destroyed by sun, rain and wind. Inside the windmill the restoration is to modern. Only the wind shaft itself is old and some parts at ground level inside the windmill. In the future this will be a congress center with Hotel accommodation and conference rooms in the buildings around. The building close to the windmill will be the restaurant in future.

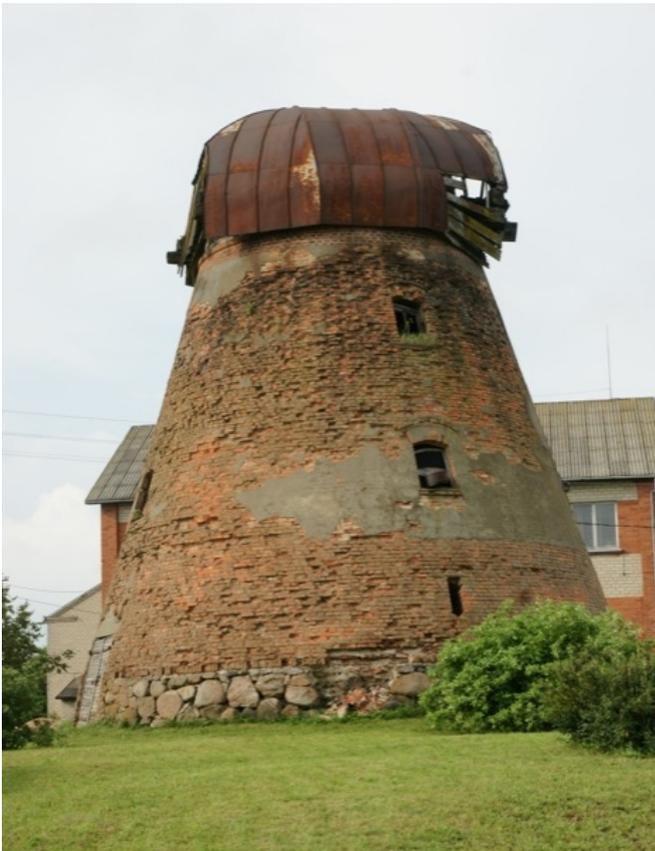
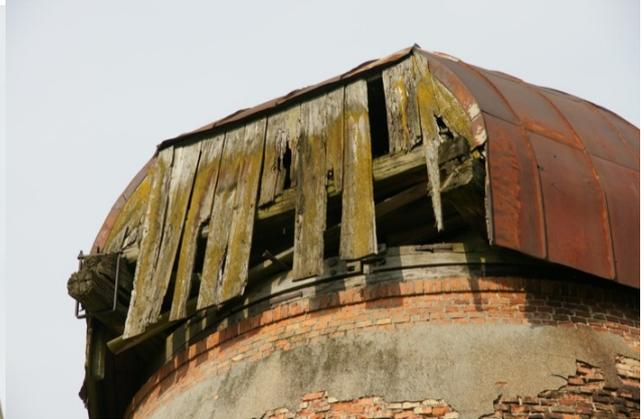
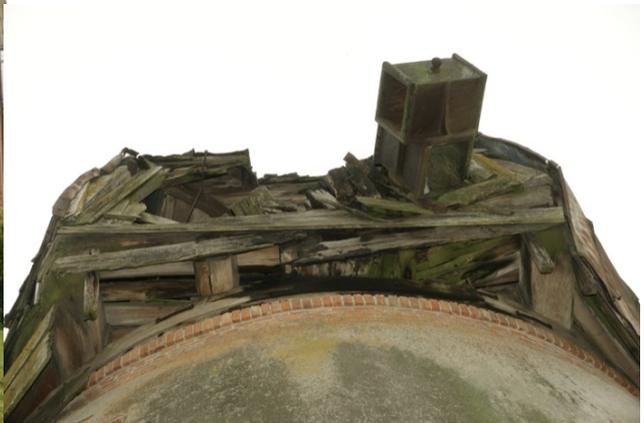
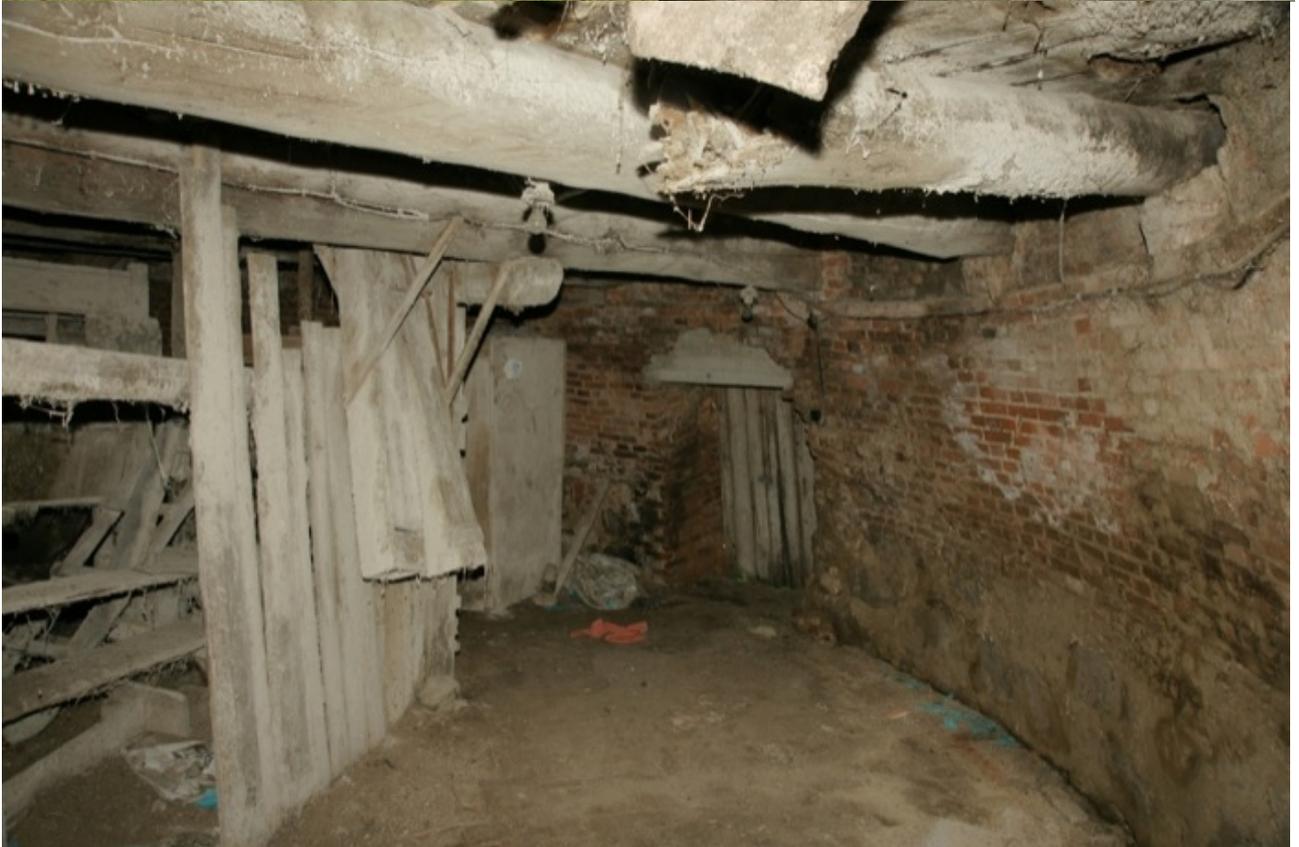
52 Kalpokai (Linkuva) Lithuania
Windmill 16

According to Alis this mill had a tale pole.

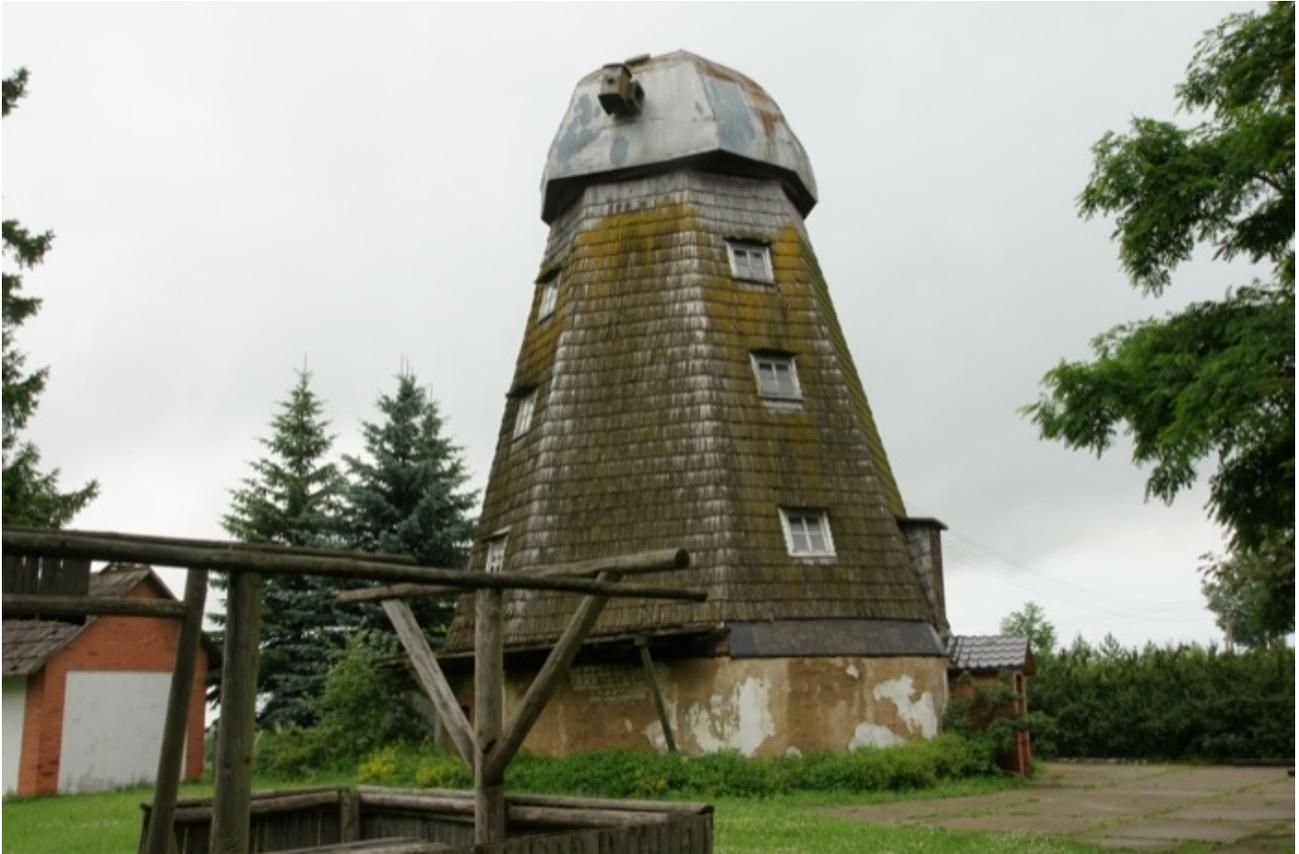
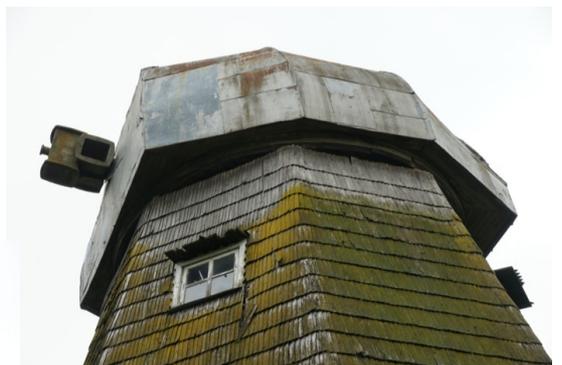
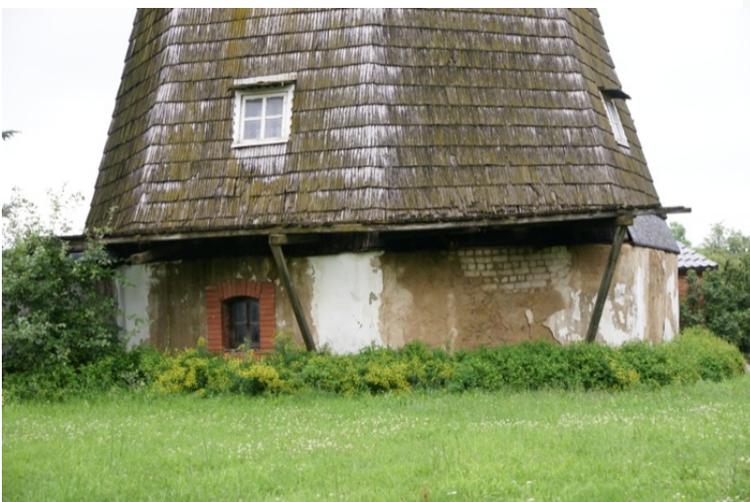
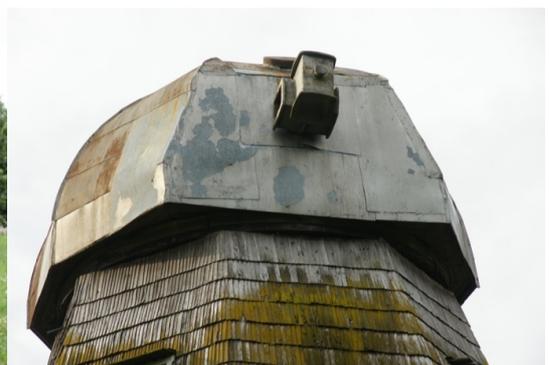
53 Ūdekai
Windmill

For sale € 13.000,- including 0.33 ha ground.
1st floor is eat and dance floor, 2nd and 3rd floors are bedrooms.
Possible only the cap is still interesting.

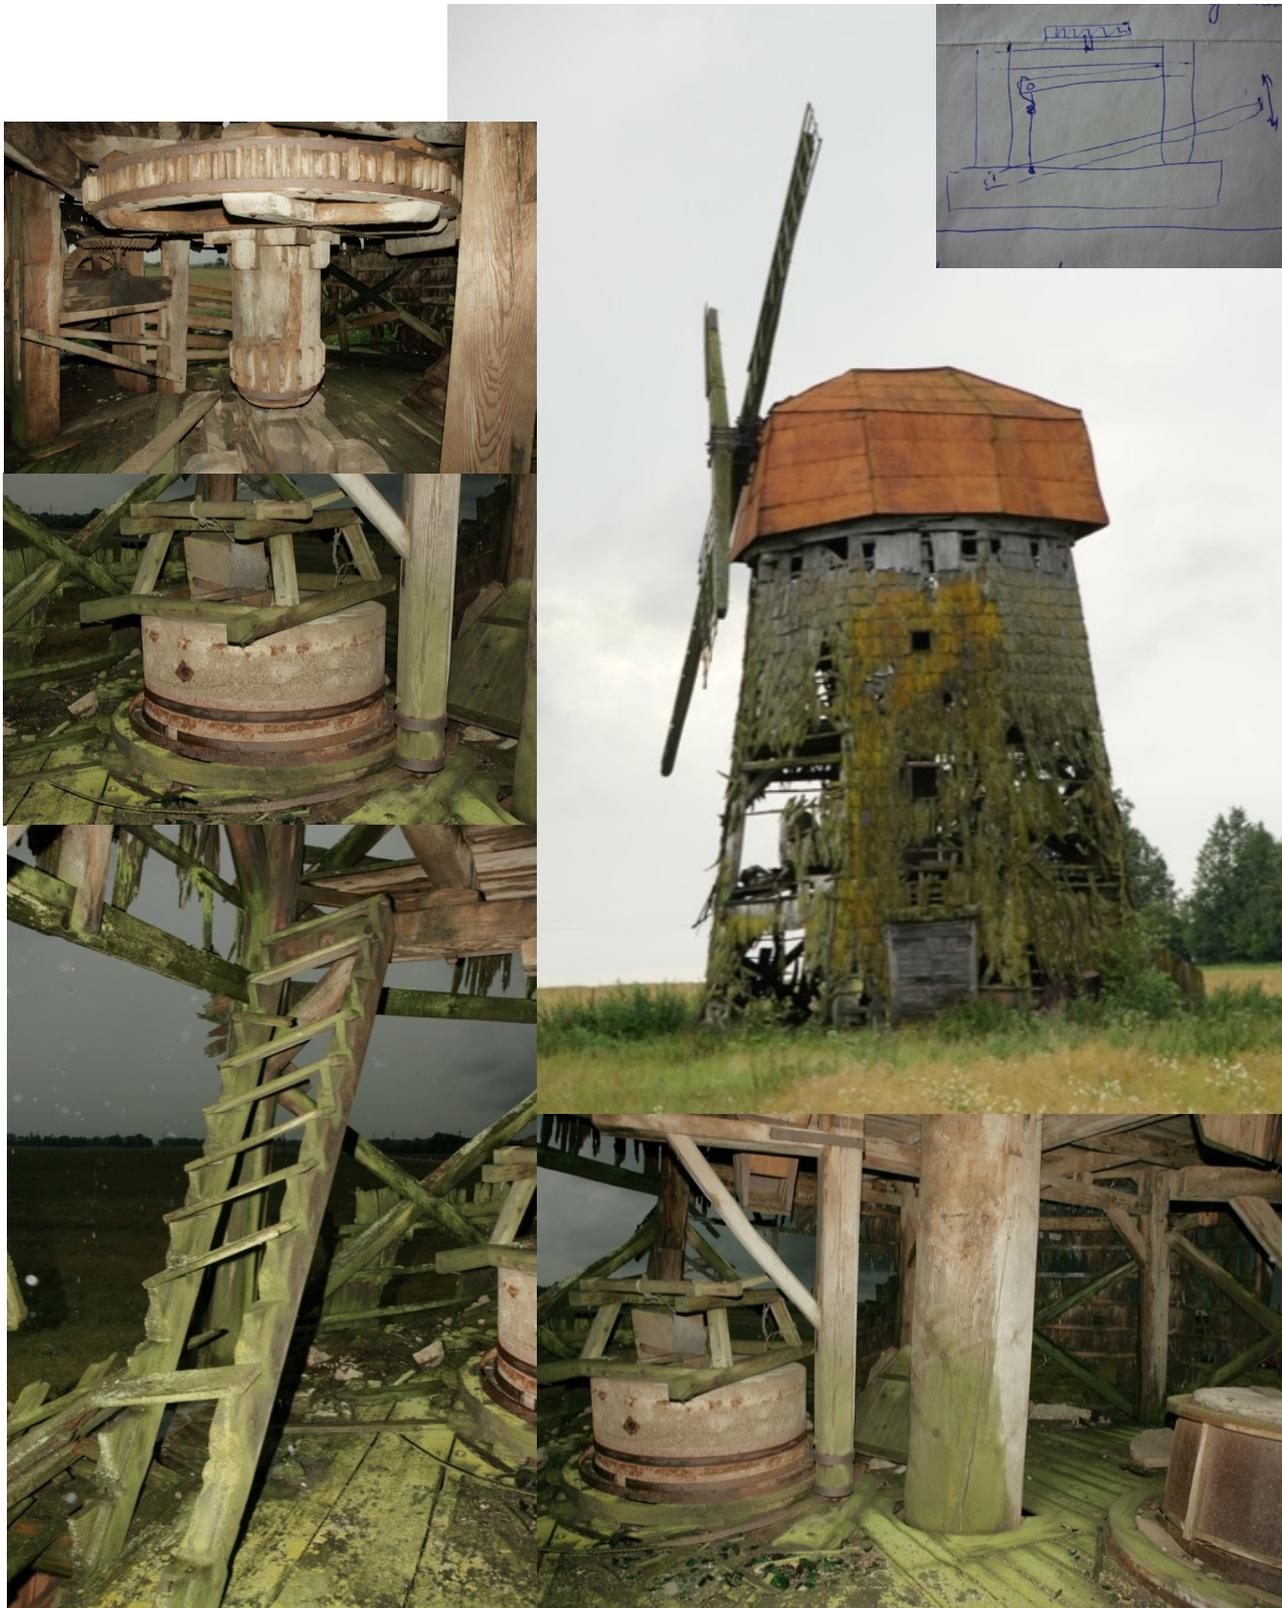
We erected the lying stairs up to the 1st floor and made photo's of mill stones still at the first floor. The first floor will come down during the next three to five years if nothing is being done. The stair was made in the old fashion according to Alis. Interesting also was the stone adjustment, see picture.

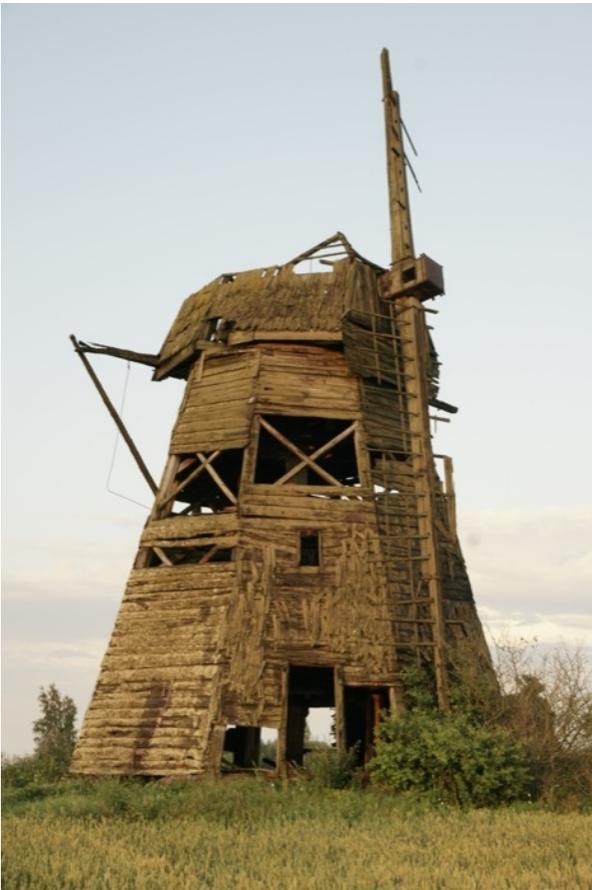
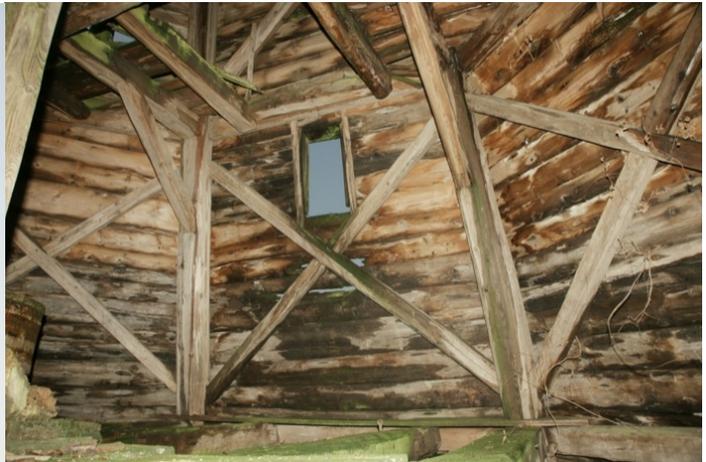
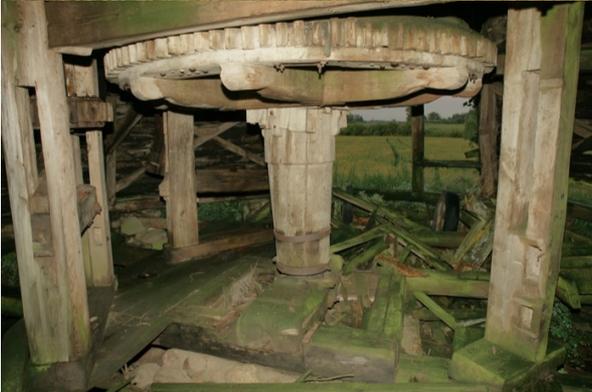
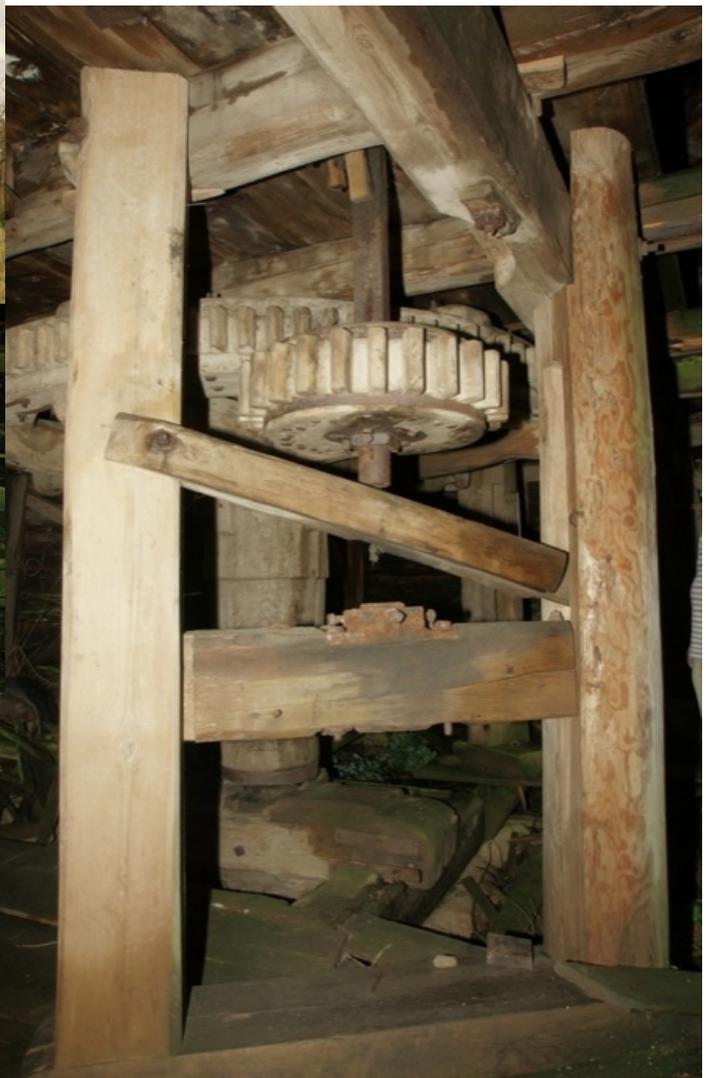
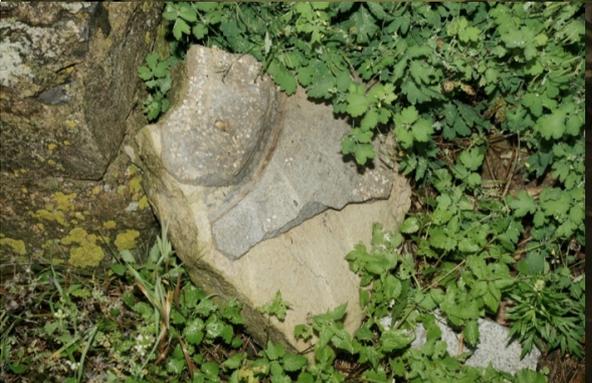
56 Gelčiai
Windmill

Three pair of stones were inside and only one sail rod, dubbel gedekt (no English translation for "dubbel gedekt").

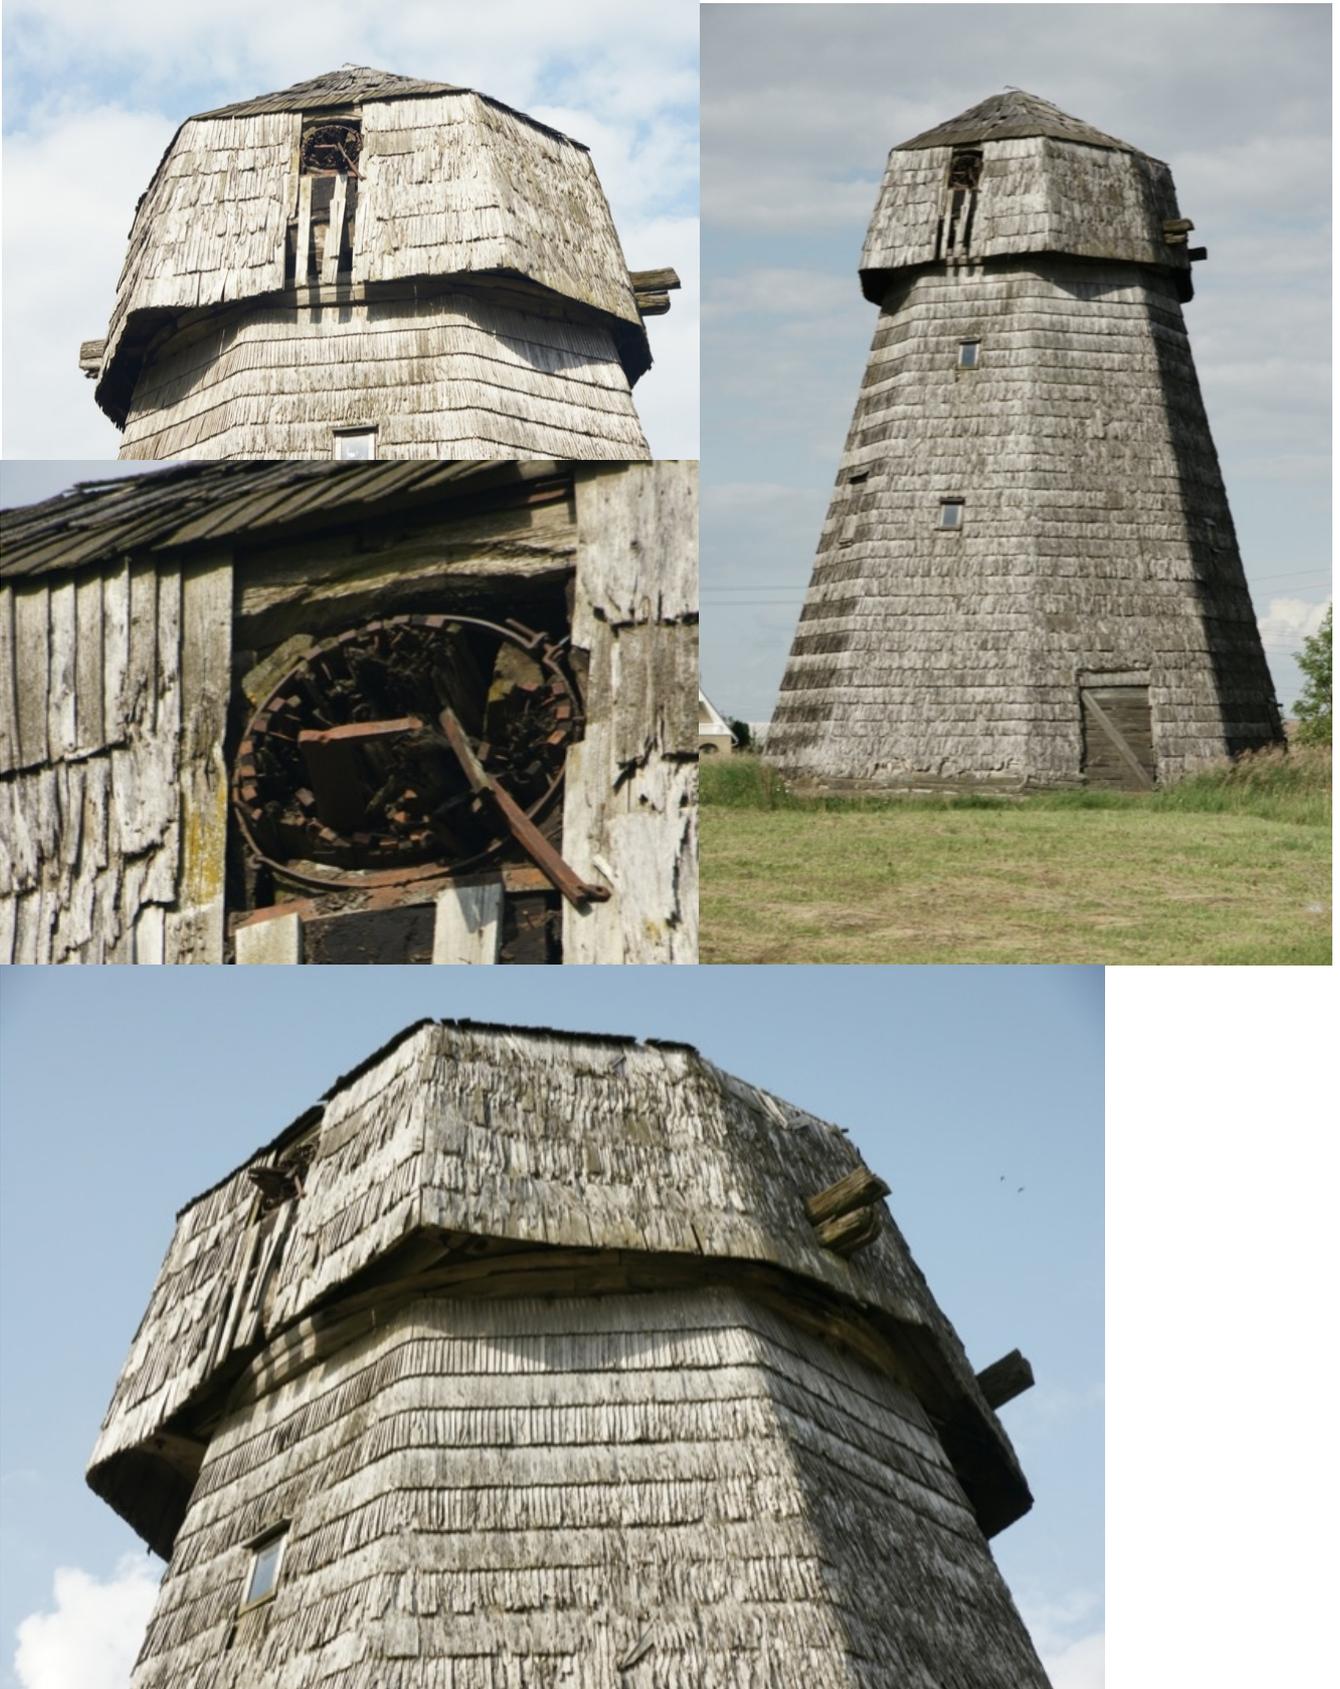
63 Alksnupiai
Windmill

Mill was closed. Inside complete.

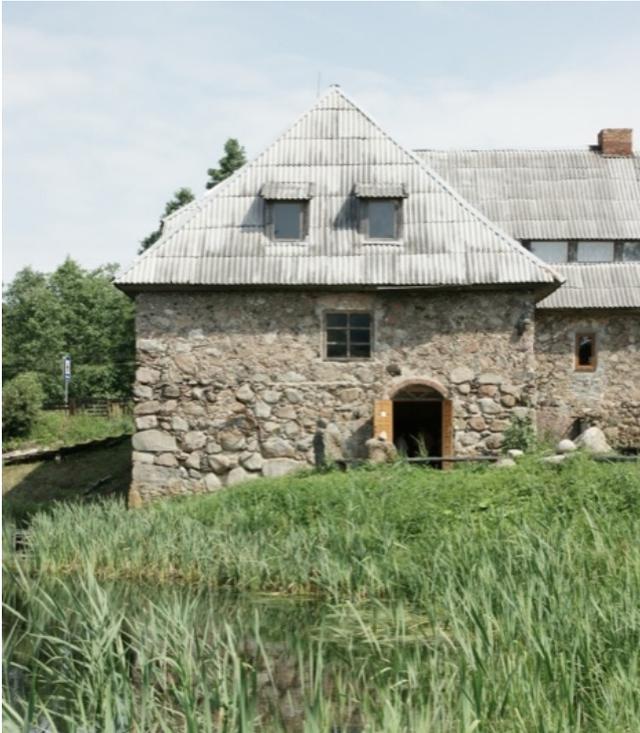
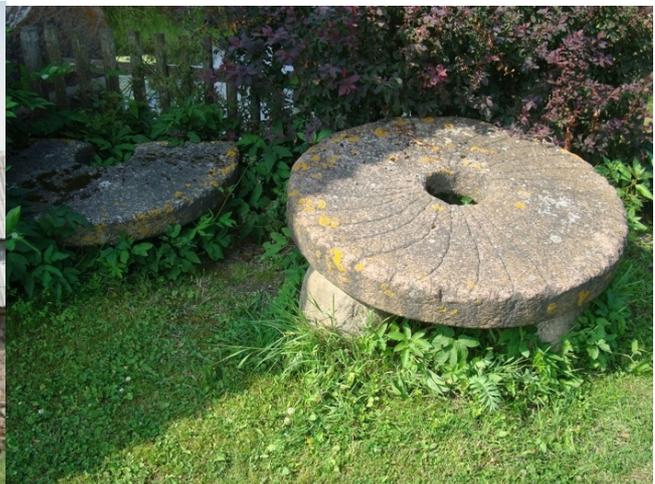
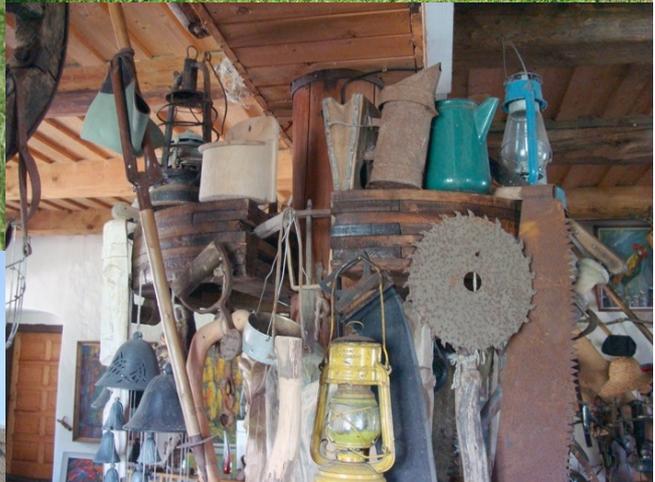
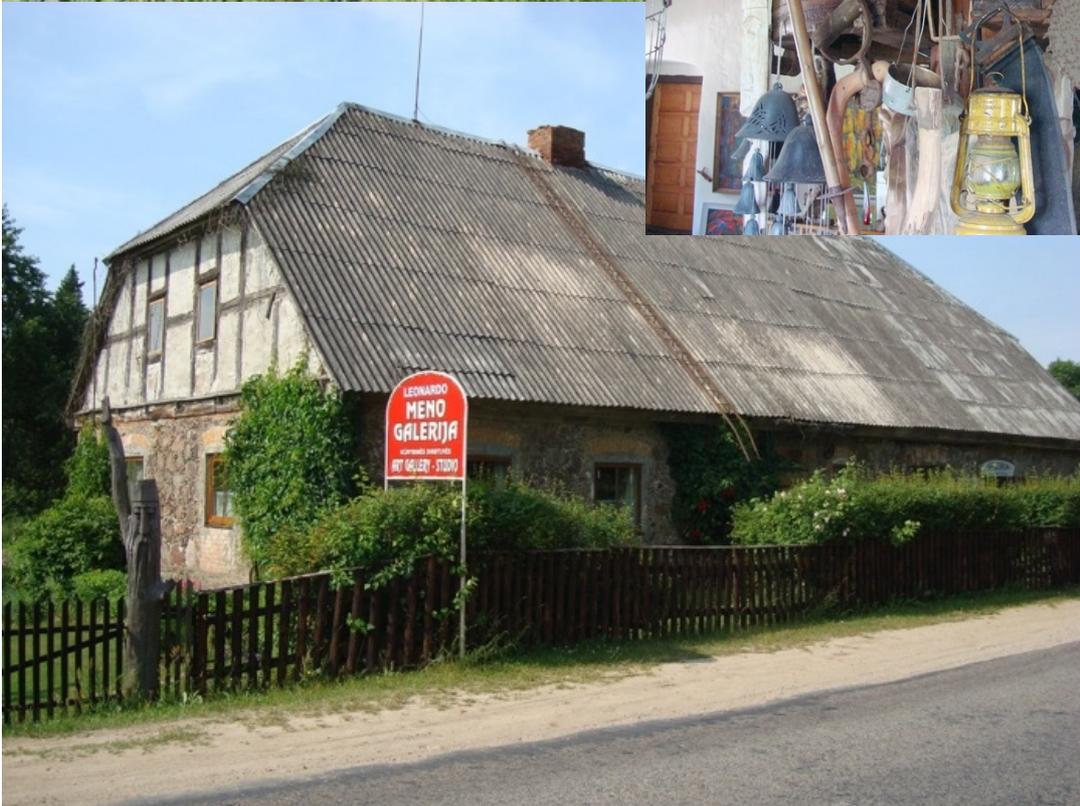
The owner (painting artist) has the mill since 1989 and found some remains underground, the mill is being used now as an Art Gallery. Mill was in operation from 1816 - 1974. The mill had three functions: mill, gardening (maybe grading) wool and shoe factory. River is called Babrungas. Snakes, rats and frogs lived in the mill for many years until 1983. Two dead bodies were found in the wall during renovation. The bellows (blaasbalg in Dutch) is from a smith around.

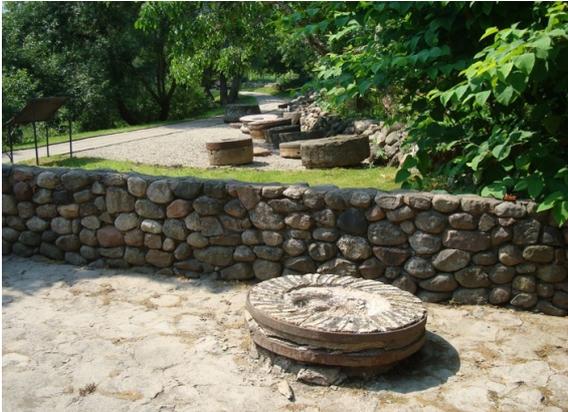
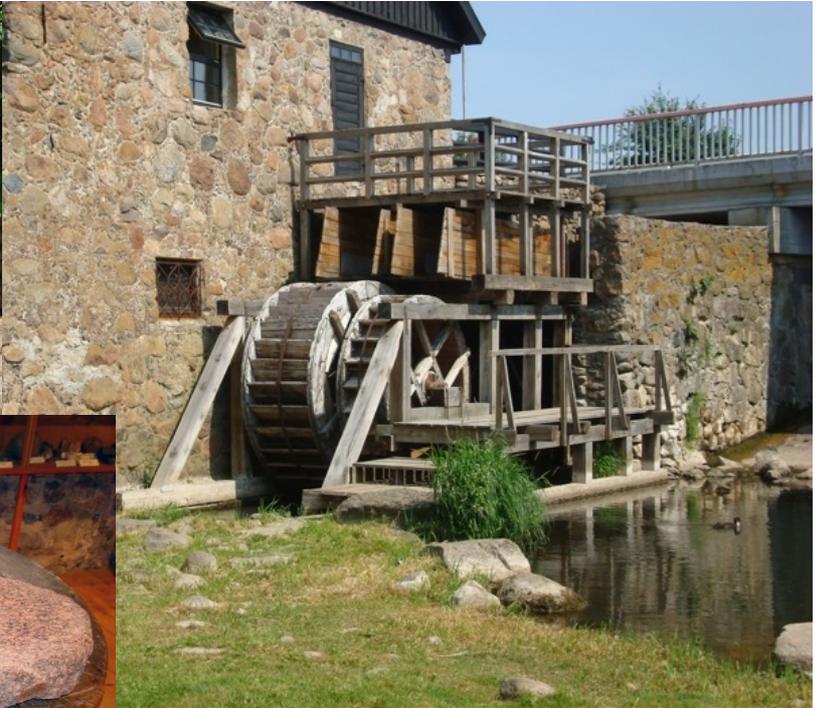
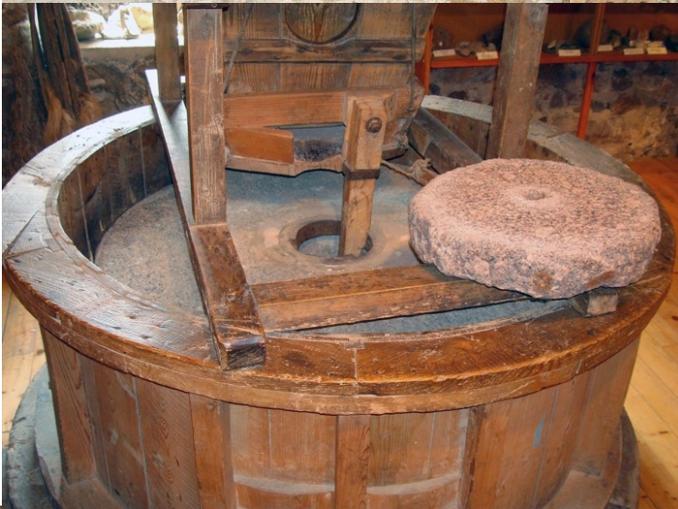
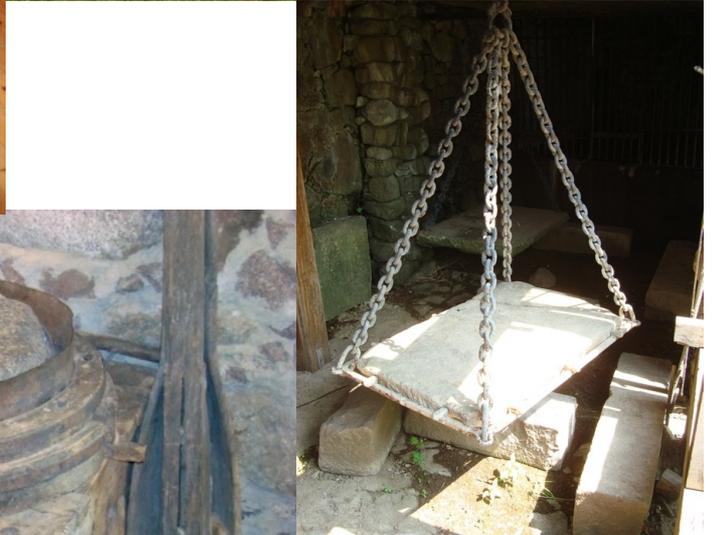
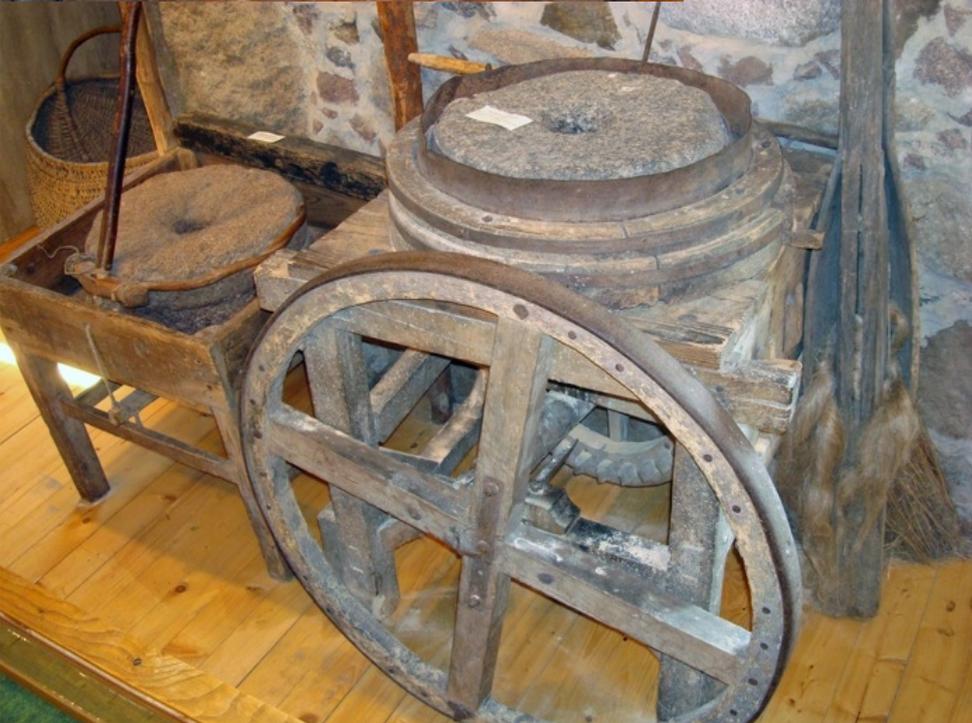
Mill on the Bartuva river with two waterwheels. Interesting hand mills with gearing inside the museum building. Upper stones of the hand mills are adjustable.

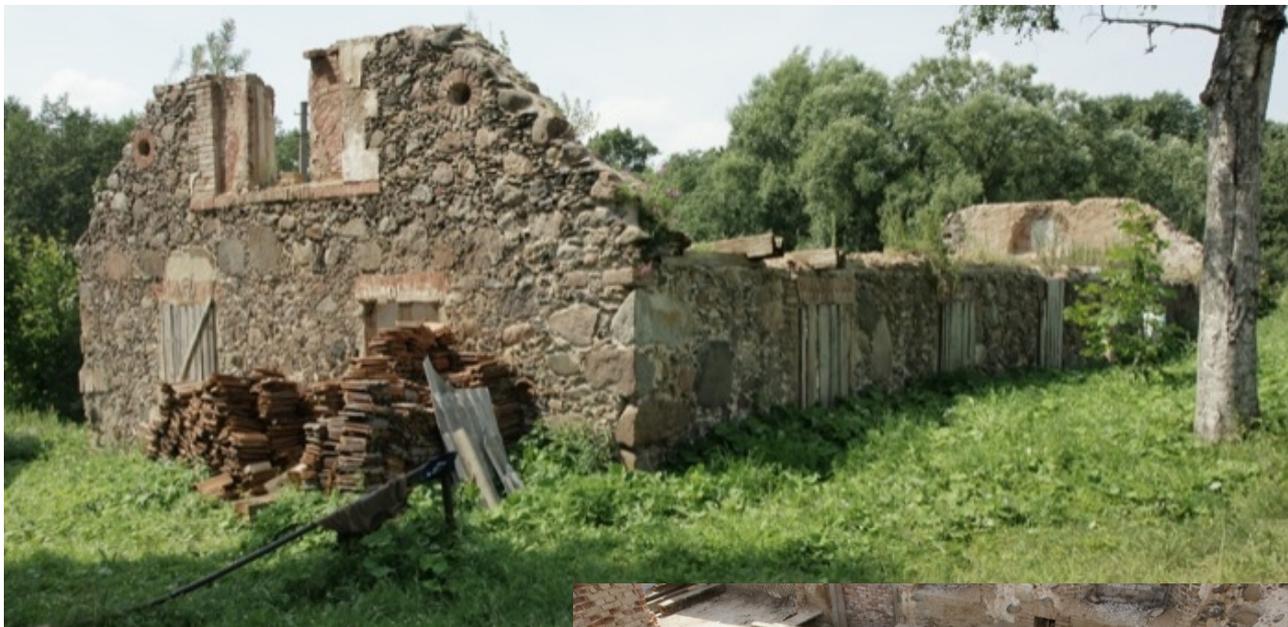
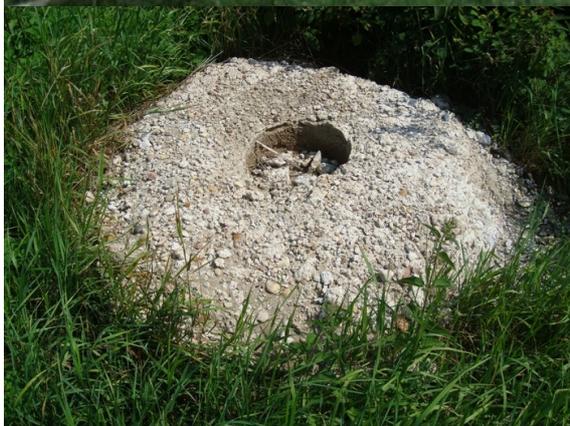
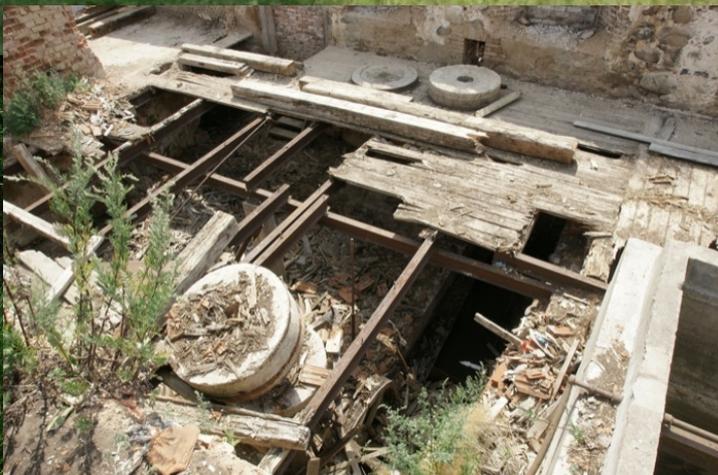
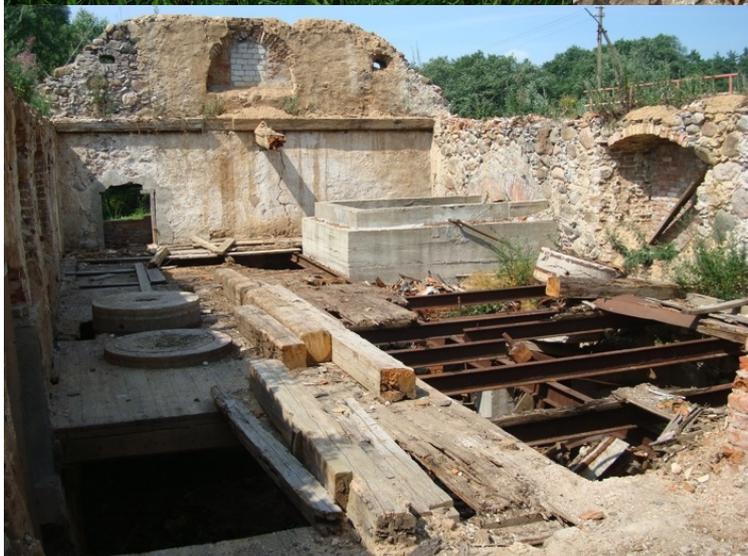
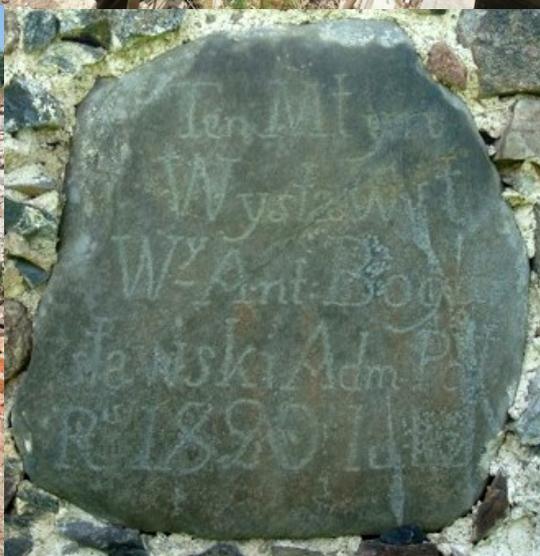
67 Darbėnai
Watermill, ruins

Lithuania 18 Will get new function, workers were cleaning.

This watermill was being cleaned and will get a new destination. Built in 1820 as can be seen from a stone in the wall. Three mill stones remains are inside and remains of gearing parts.

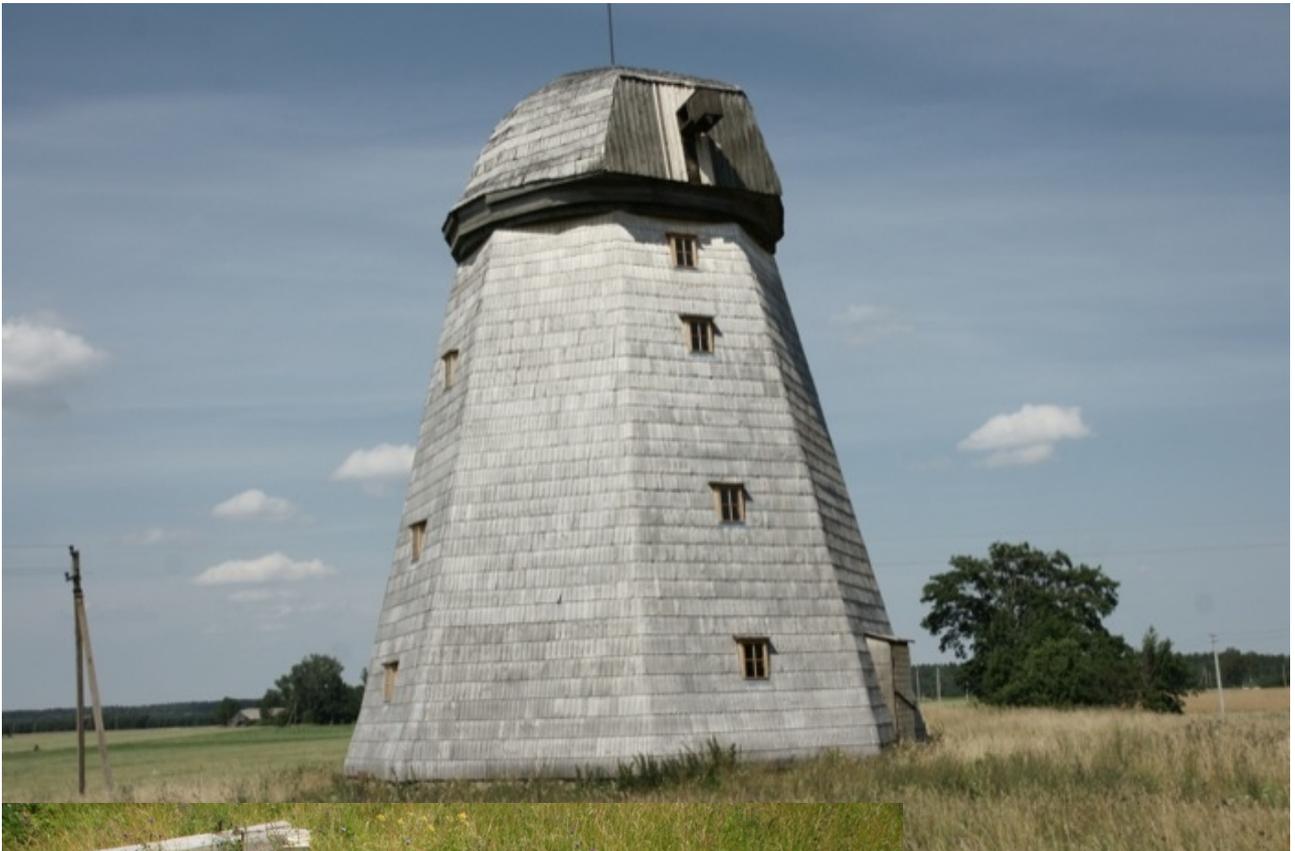
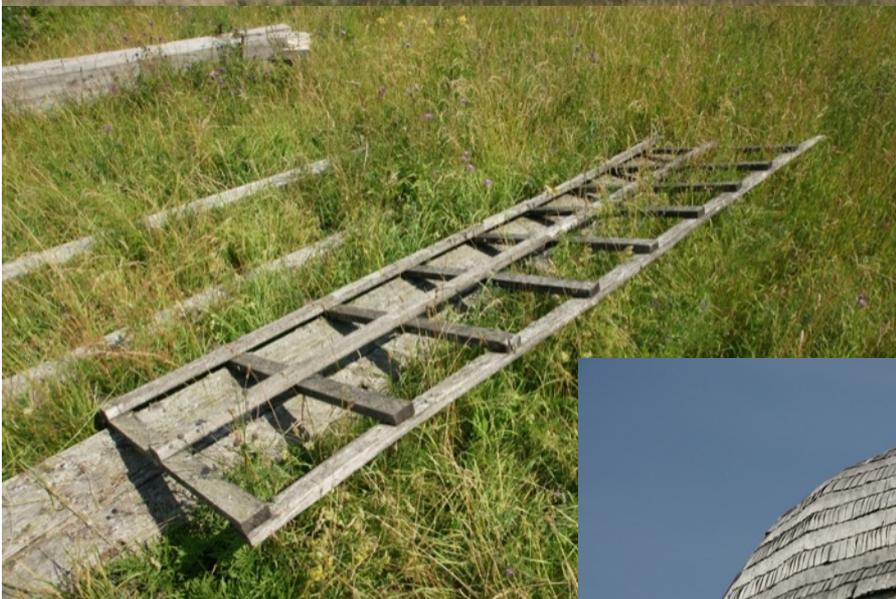
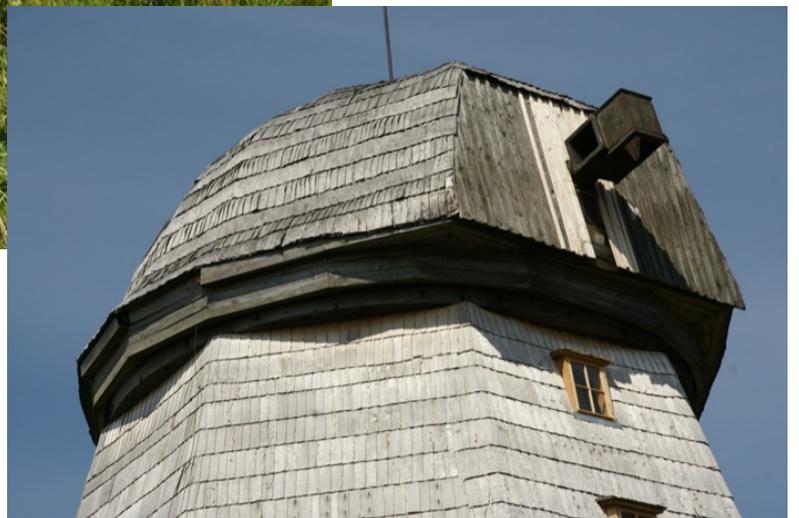
68 Lazdininkai
Windmill

Complete inside.
