70 visited Baltic mills in 2009
1 page per mill

Tour in July 2009 to 70 Baltic Mills in Saaremaa, Estonia, Latvia and Lithuania

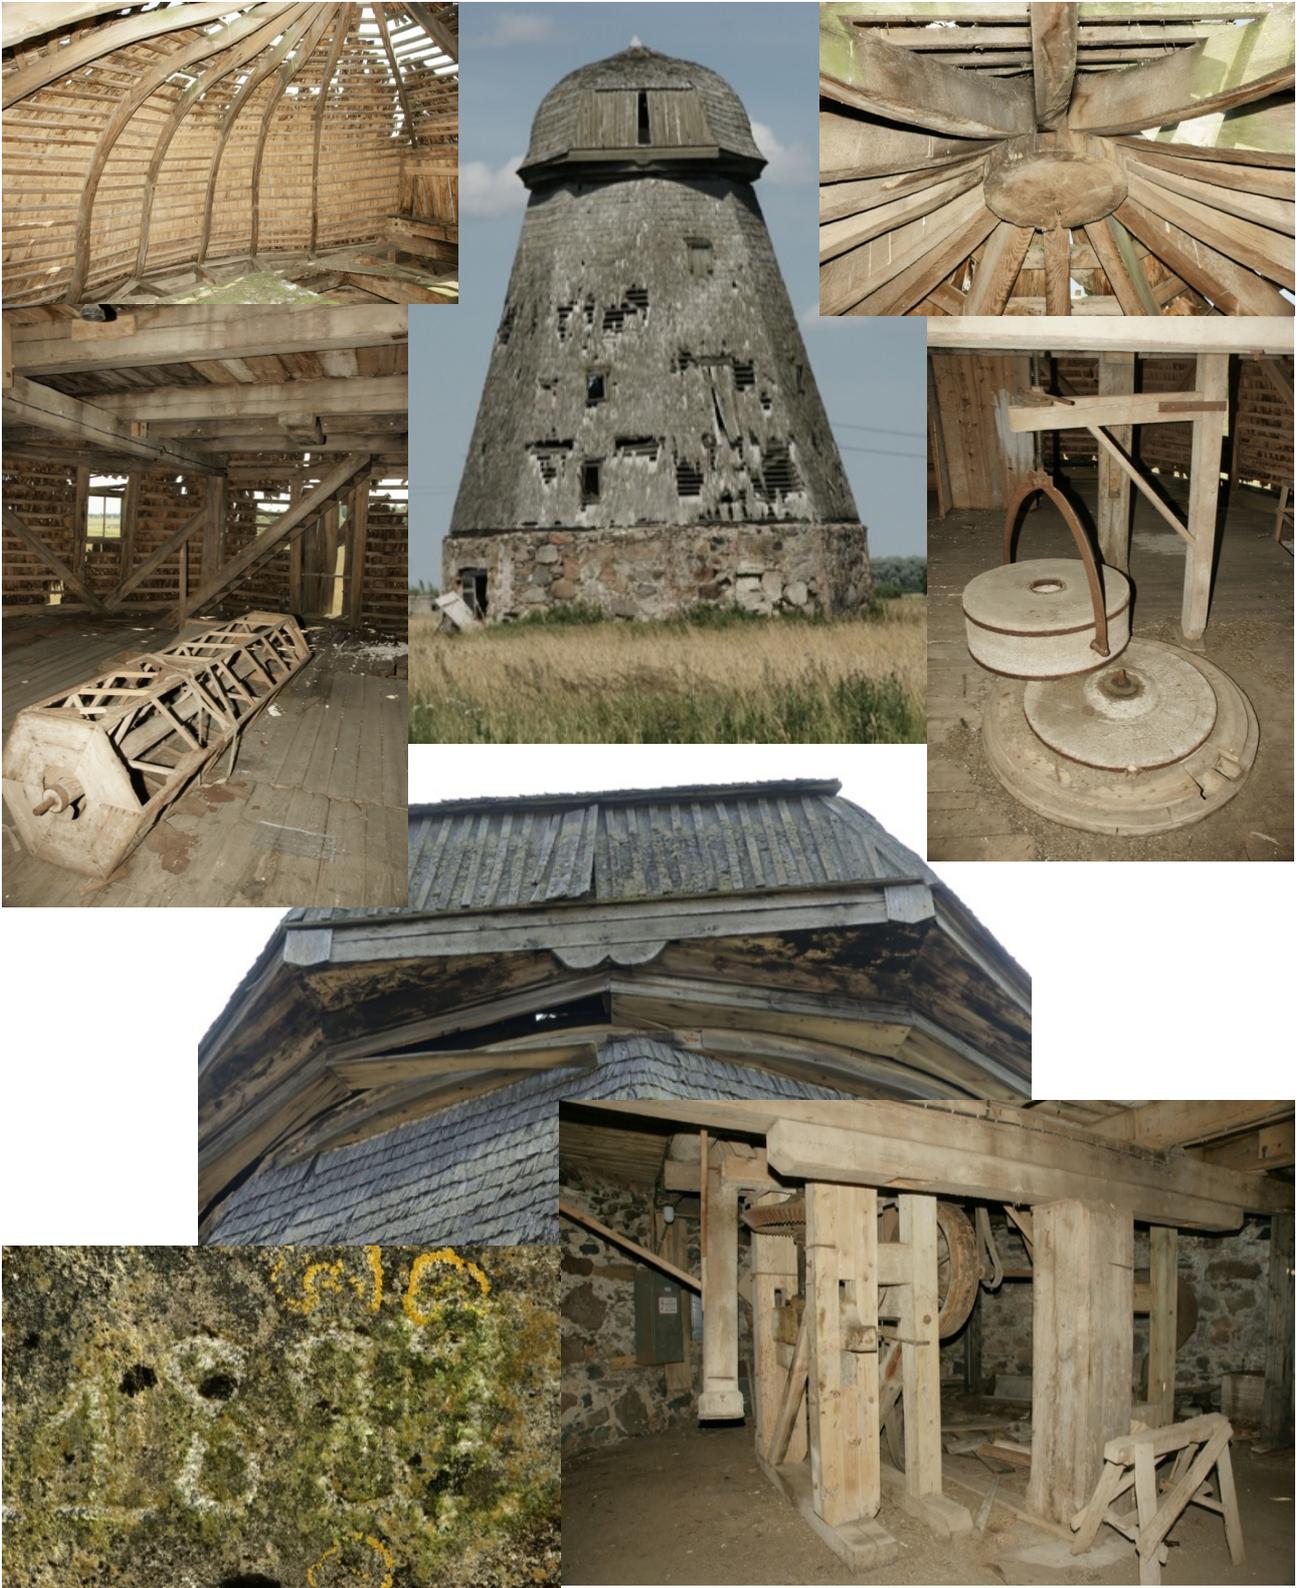
69 Ķaķišķe
Windmill

Originally a gallery mill, built in 1889. Between 1960-1970 rebuild to electric traction. Partly complete, door was forced open before our visit.

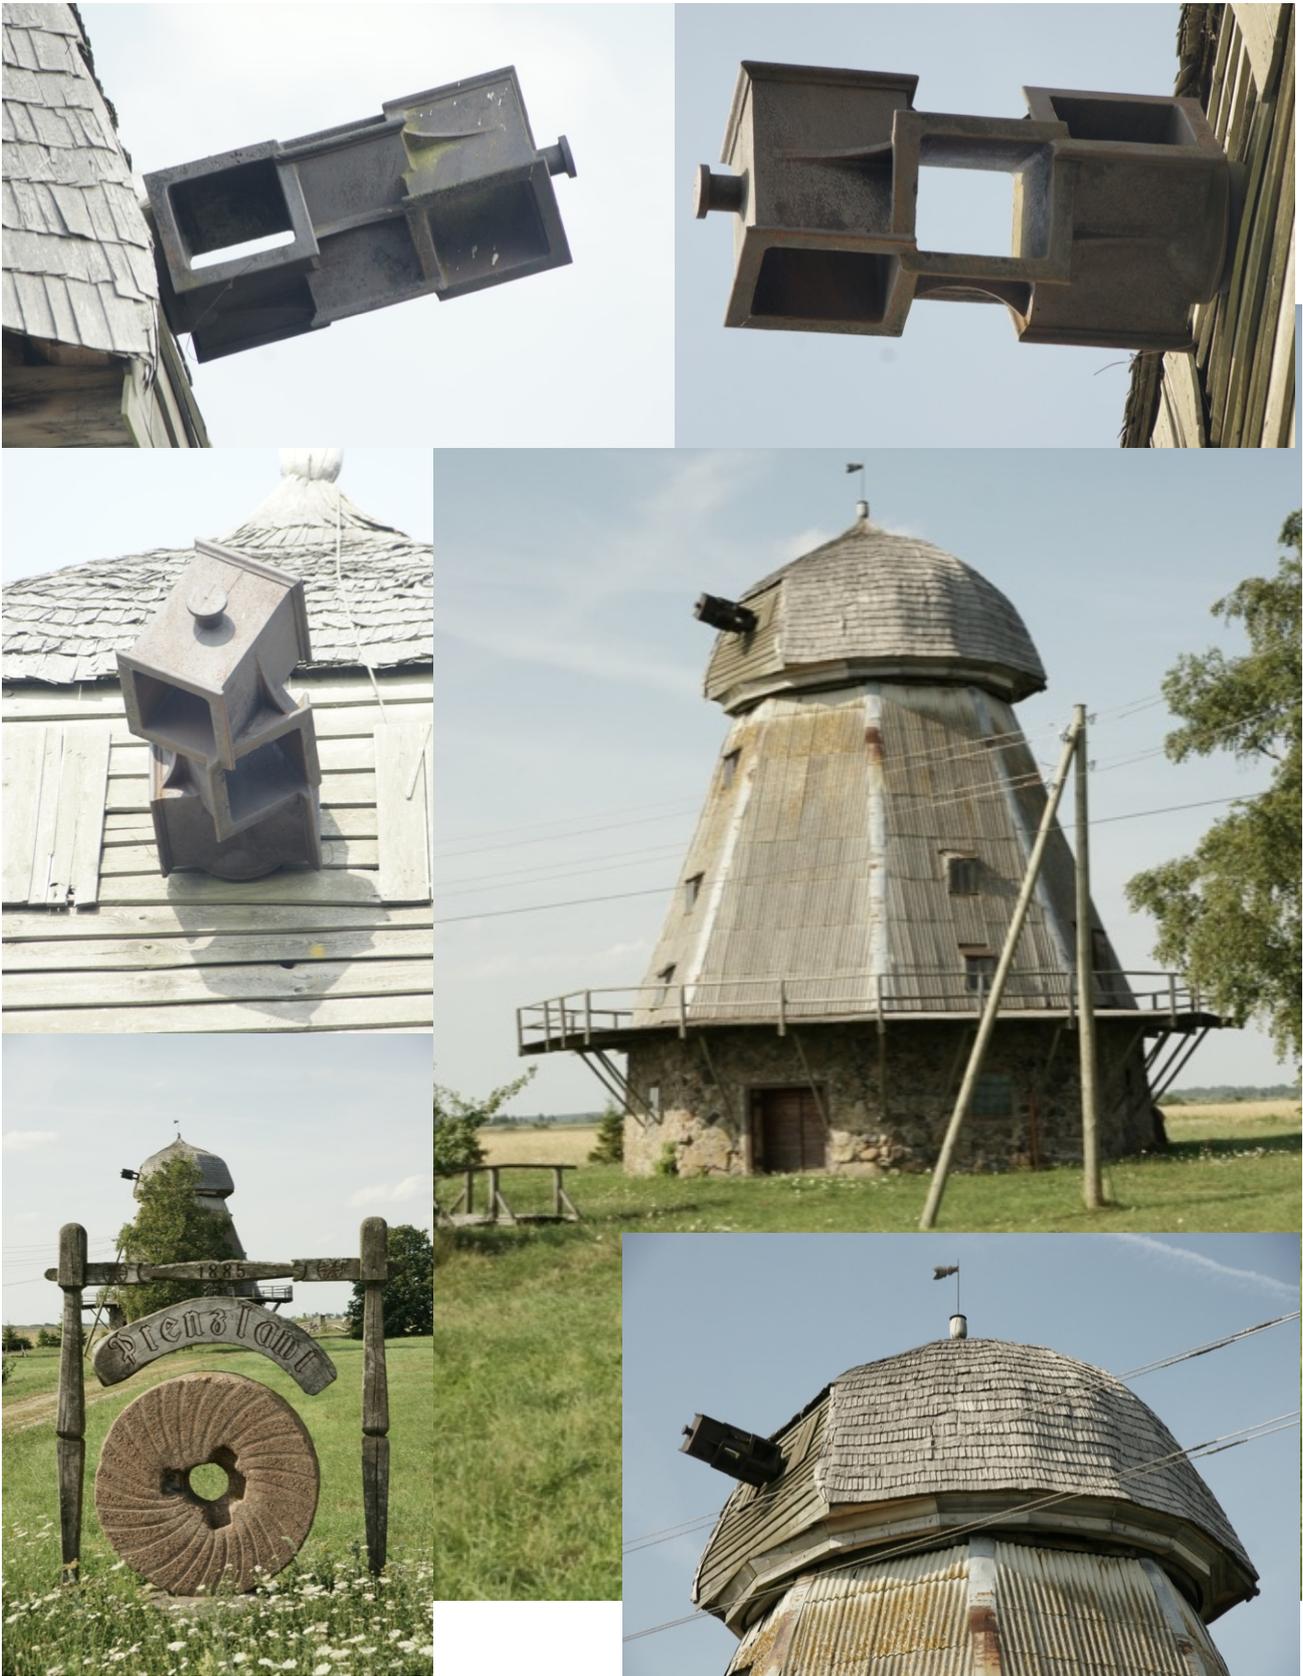
70 Rude(s)
Windmill

Built in 1885. Owner is Kupšis Arnis who lives in Otanki.
